The 2007 Noto Peninsula, Japan Earthquake (M_w 6.7): Damage to Wooden Structures

Masumi Yamada¹, Sun-Cheon Park¹, and Jim Mori²

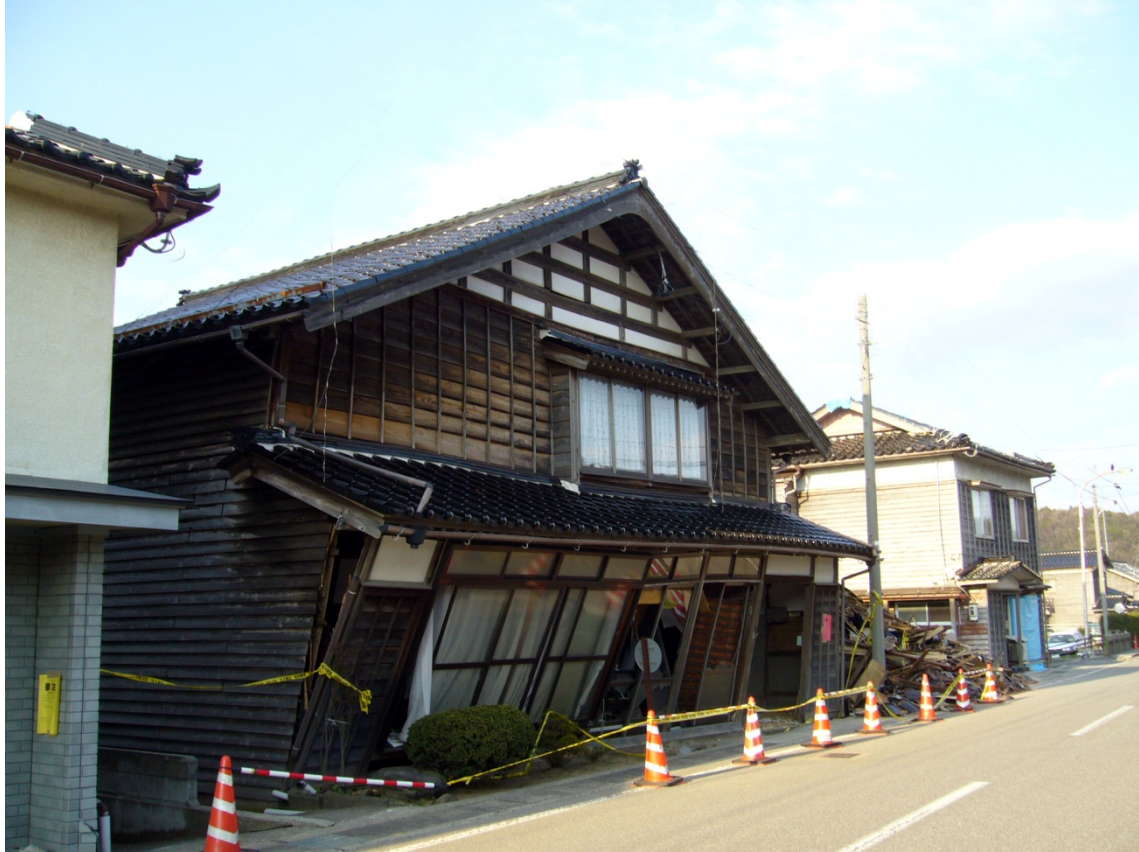
Figure 3: A house with severe damage on columns (Rank C). The columns are tilting forward more than 20 deg. and still standing.

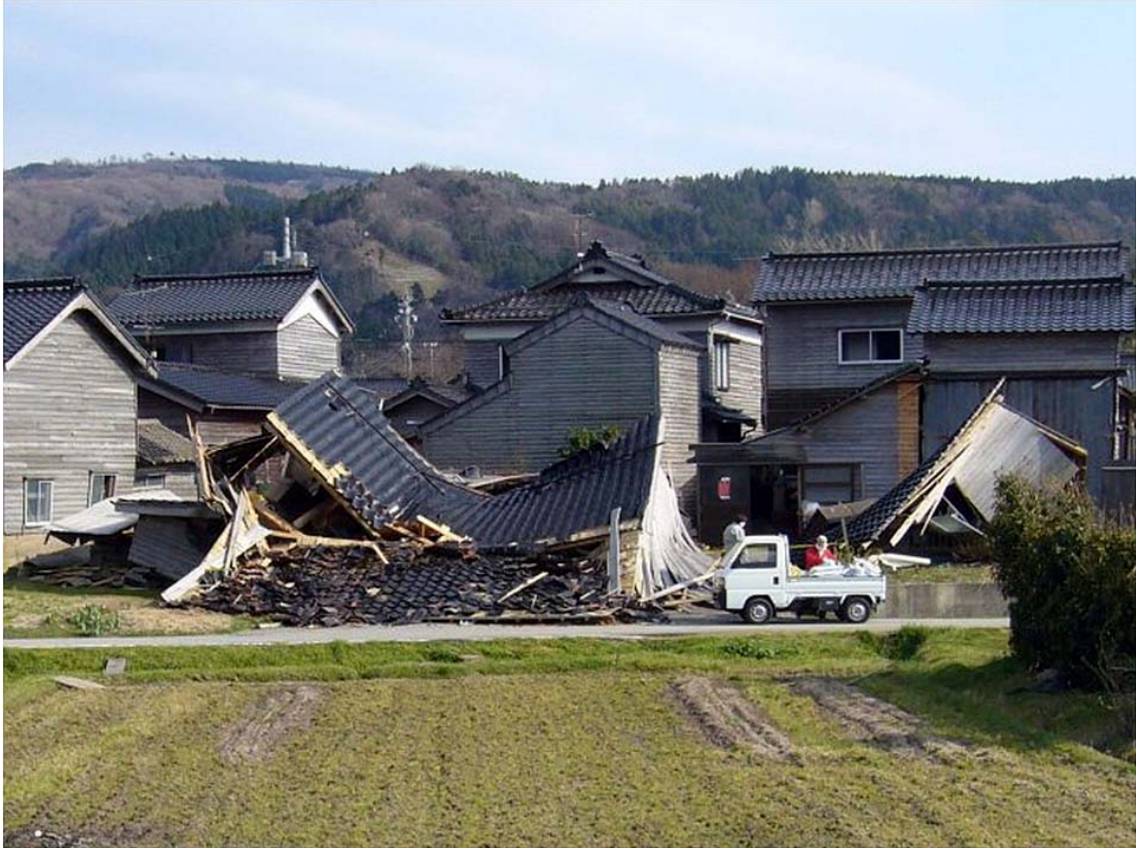
Figure 4: A totally collapsed house (Rank C).

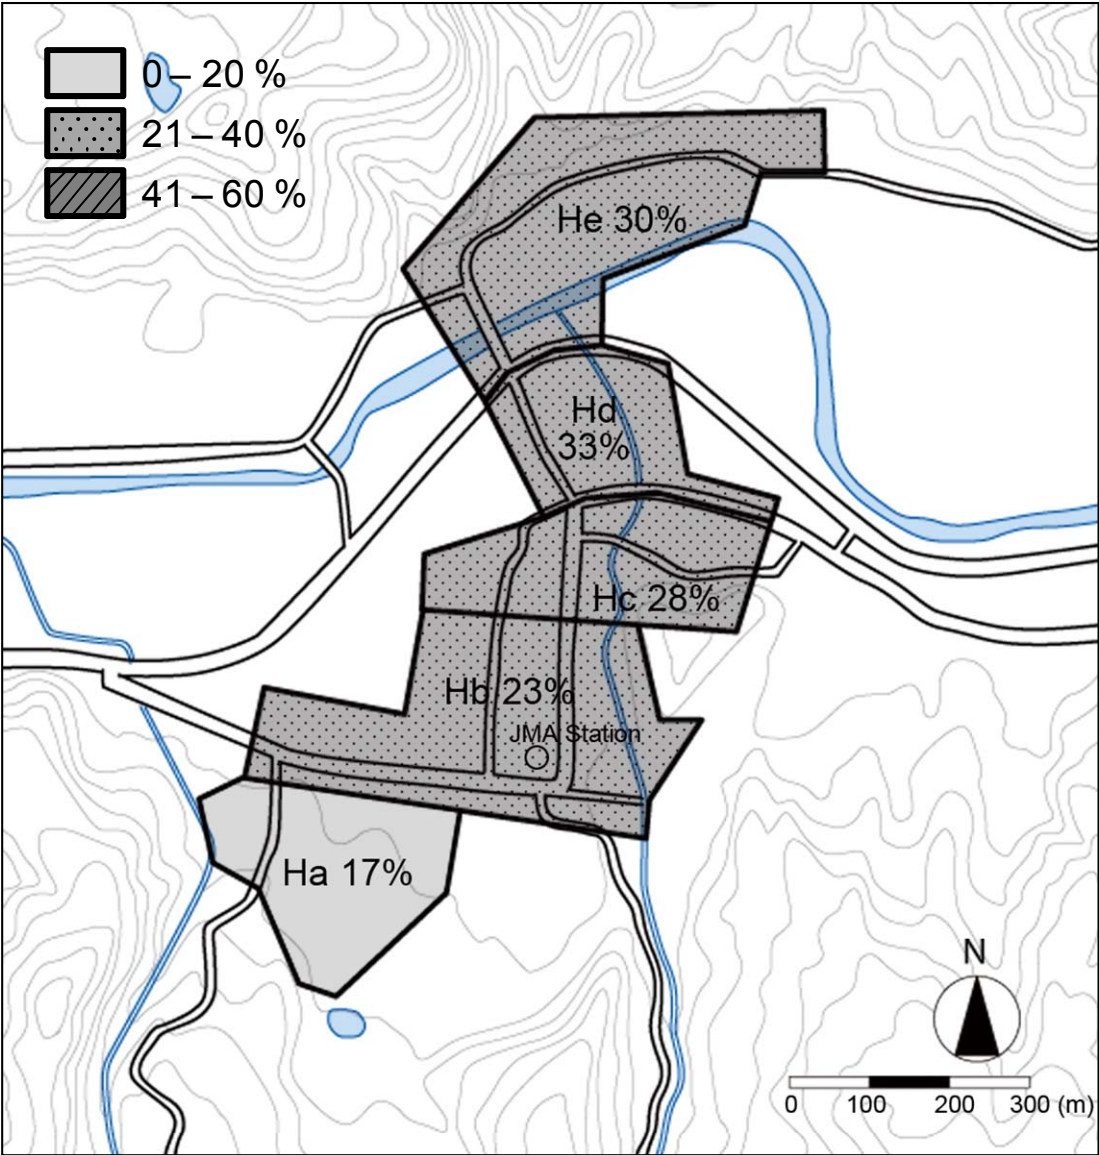
(a) Hashiride district

In Hashiride, the damage ratio is almost same across the different locations, and the occurrence of Rank C damage is about 20~30% of all wooden structures (Figure 5(a)). Hashiride includes a business district in sections Hb and Hc, and many stores were severely damaged due to the large open spaces on the first floor. In Touge, the occurrence of Rank C damage is 10 to 52%, depending on the location. The hill side area (section Ta in Figure 5(b)) has less damage whereas the area close to a river has larger damage (section Tb in Figure 5(b)).

Figure 5: Areas of the damage survey (shaded areas) and the damage ratio of rank C wooden structures.

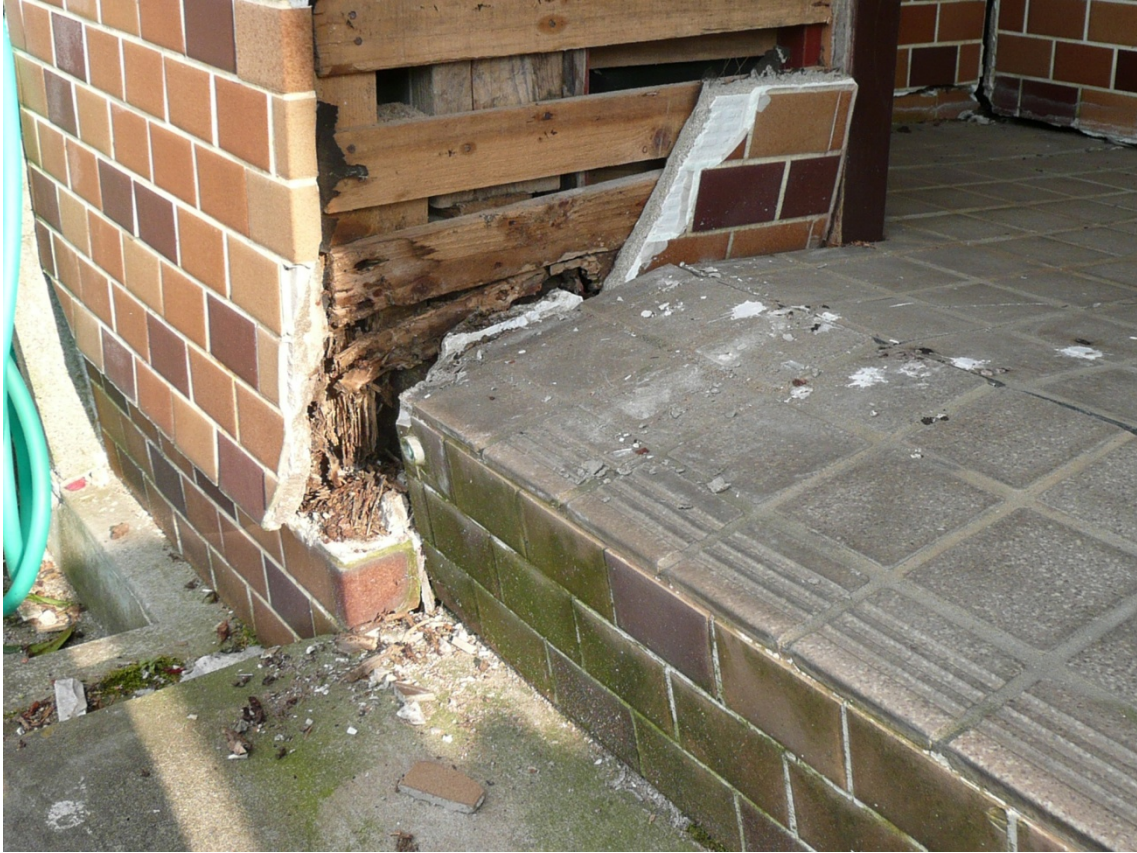
Typical damage we observed were cracks in the wall, exfoliation of the wall material, fallen roof tiles, shifting of roof tiles, and displacements of columns. We have also observed many instances of termite infestations and wood decay on the structural components, especially in houses with severe damage (Figure 6). These environmental degradations critically decreased the seismic performance of the wooden structures.

Figure 6: Termite damage on columns.
