# 1 **Wooden building damage analysis in Mashiki** 2 **town for the 2016 Kumamoto earthquakes on** 3 **April 14 and 16**

4 **Masumi Yamada<sup>a)</sup>, Junzo Ohmura<sup>b)</sup>, and Hiroyuki Goto<sup>c)</sup>**

5 The 2016 Kumamoto earthquakes caused serious building damage in Mashiki town.  
6 Since two large earthquakes occurred within an interval of 28 hours, it is difficult  
7 to separate the damage caused by each of these earthquakes. We analyzed aerial  
8 photos of the center of Mashiki town taken before and after the second event, which  
9 allow us to separate the damage due to the two earthquakes. Our analysis shows that  
10 building damage was concentrated especially on the river terrace of the Akitsu river,  
11 and there were almost no collapsed buildings in the south of the damaged area. The  
12 pattern of damage distribution of the two events was similar, which suggests that  
13 the damage to the wooden buildings was caused by local conditions. The analysis  
14 of past aerial photos showed that the heterogeneity of the damage distribution is  
15 difficult to explain by only the building age. The cause of this heterogeneity was

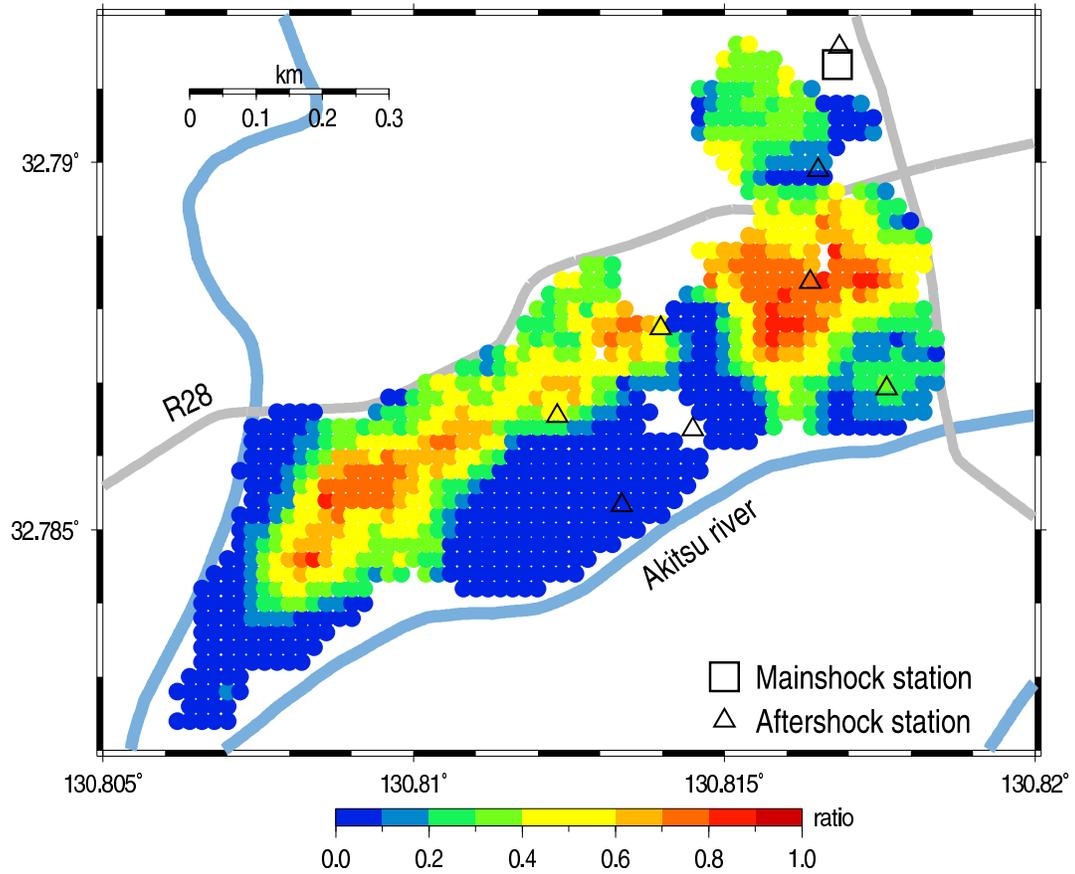
136 Figure 5 shows the ratio of D5 (story failure) buildings to all buildings, detected from the  
137 field survey. The distribution of D5 buildings was in a good agreement with our photo analysis  
138 shown in Figure 7. This is consistent with our expectation that most of the collapsed buildings  
139 identified from the aerial photos were story-collapsed buildings.

**Figure 5.** Ratio of D5 (story-collapsed) wooden buildings detected from the field survey conducted in June 2016. The square and triangle symbols are the same stations as those indicated in Figure 2.

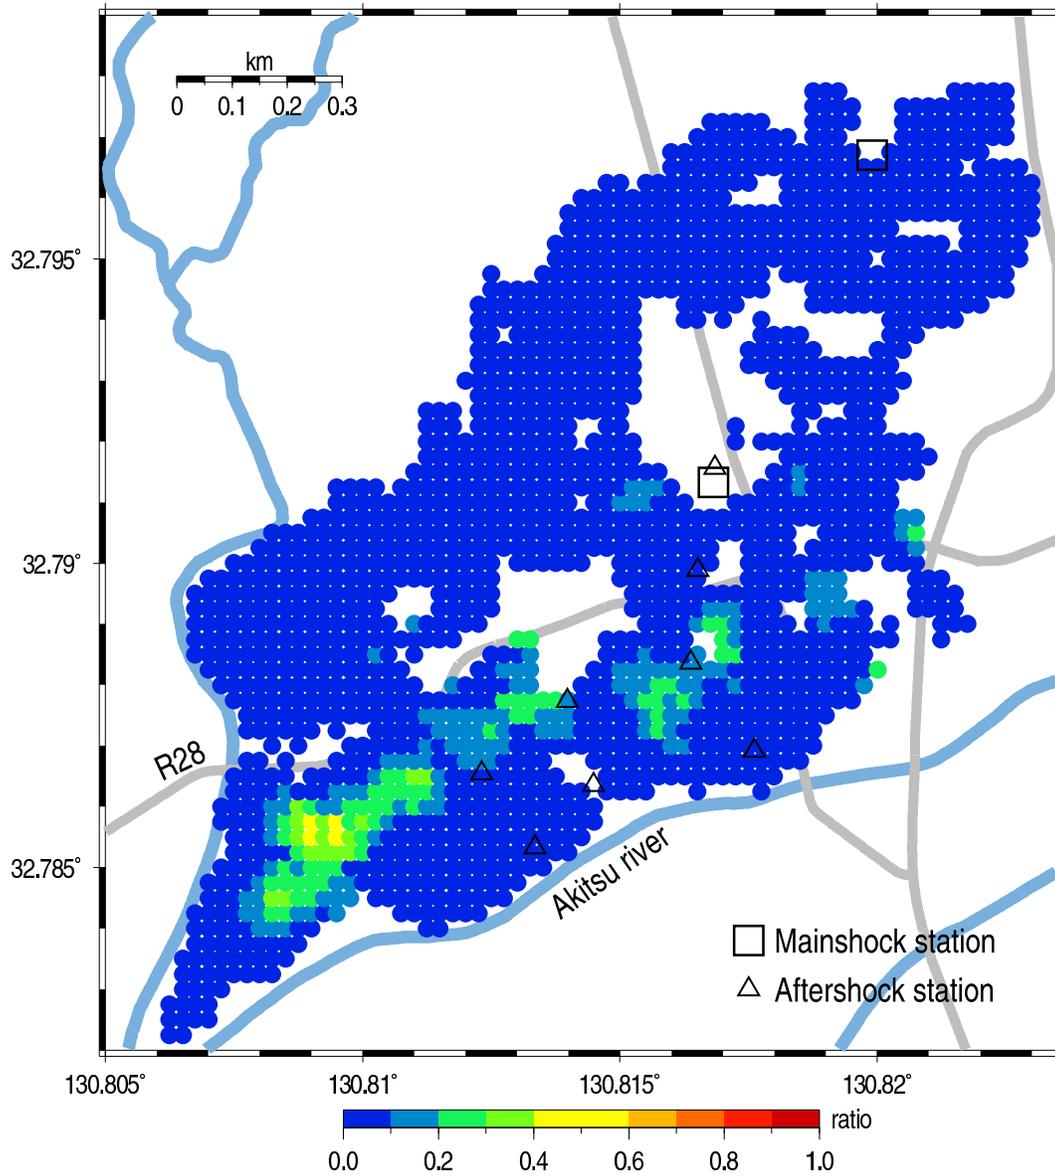
127 Figures 6 and 7 show the damage distributions identified from the aerial photo analysis before  
128 and after the April 16 event. The color of each circle indicates the ratio of collapsed buildings  
129 within a radius of 50 m. Each circle constitutes a grid point with an interval of  $0.00025^\circ$  (about  
130 25 m). The grid points with at least 10 buildings are shown in the figures.

131 We analyzed 2,915 buildings and identified 78 and 378 collapsed buildings after the April  
132 14 and 16 events, respectively. Although the number of damaged buildings from the April 16  
133 event was about four times more than that from the April 14 event, the pattern of the distribution  
134 of the damaged area was similar. The most heavily damaged parts were located in the northern  
135 part of the area between Route 28 and the Akitsu river.

192 The similarity of the pattern of damage after the April 14 and April 16 earthquakes, shown  
193 in Figures 6 and 7, respectively, suggests that the damage of the wooden structures was caused  
194 by the local conditions, such as the seismic performance of the buildings or the subsurface soil  
195 structures, rather than the effects from the earthquake source. Small surface ruptures (red lines  
196 shown in Figure 2) appeared after the April 16 event very close to the damaged area (Geospatial  
197 Information Authority of Japan, 2016a), but this surface rupture was not observed on April 15,  
198 during the interval between the April 14 and 16 events (Shirahama et al., 2016). Therefore,  
199 it is difficult to explain the similar pattern of damage distribution as due to the effects of the  
200 surface rupture, such as static deformation or the hanging wall effect. The age of the buildings

**Figure 6.** Ratio of collapsed buildings detected from the aerial photo analysis before the April 16 event. The square and triangle symbols are the same stations as those indicated in Figure 2.

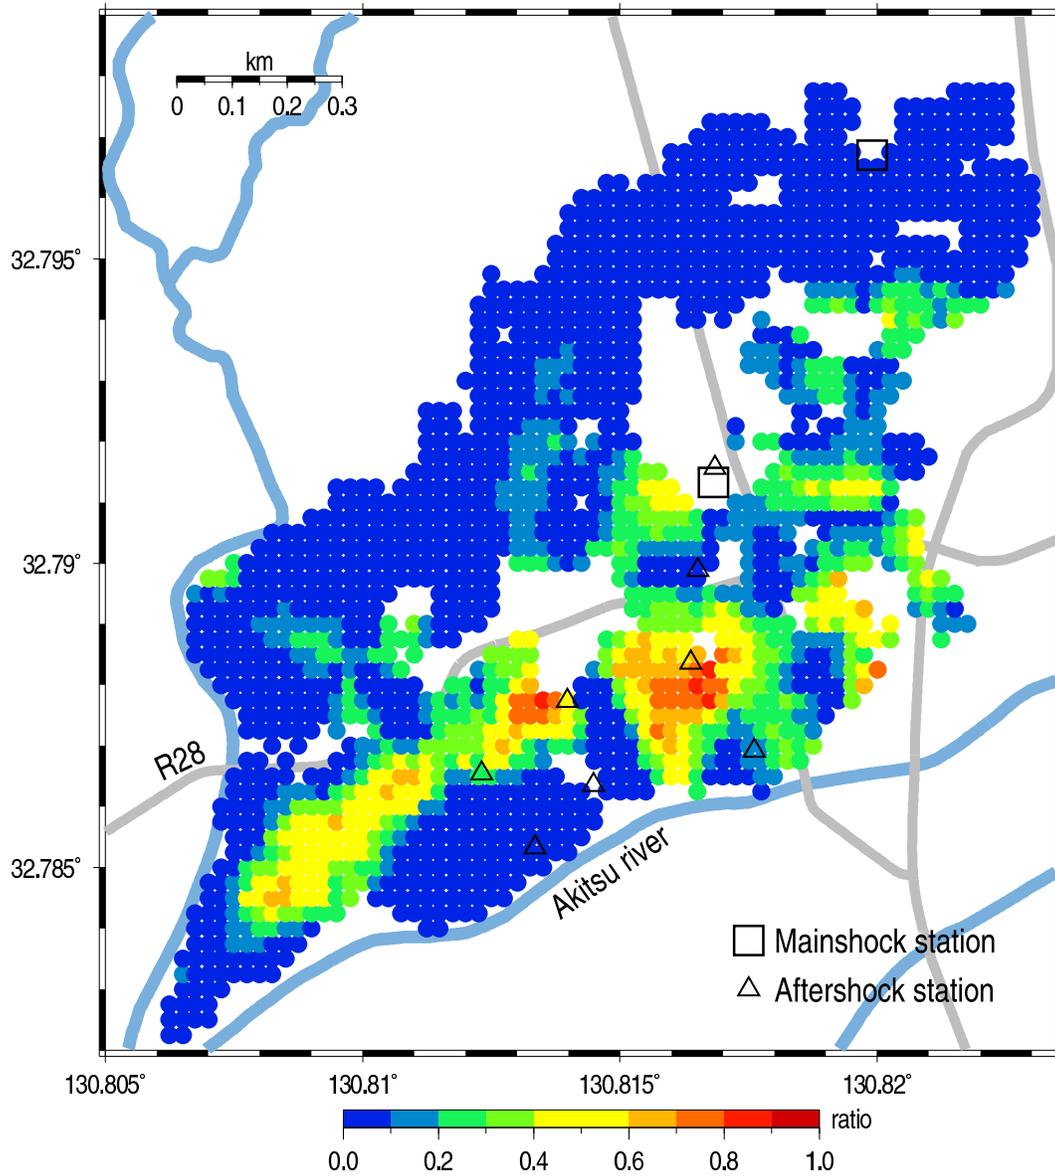
**Figure 7.** Ratio of collapsed buildings detected from the aerial photo analysis after the April 16 event. The square and triangle symbols are the same stations as those indicated in Figure 2.

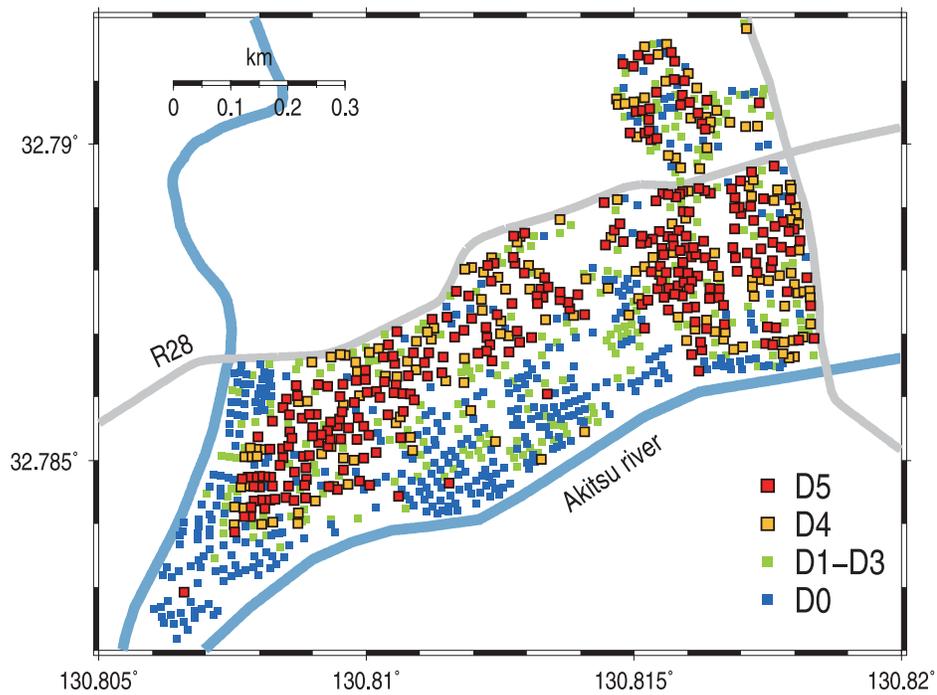
140 We compared the damage condition of each building from the field survey and aerial photo  
141 analysis, and the results are shown in Table 1 (see also Figures 8, 9, and 10). The total number  
142 of buildings that surveyed by both the field survey and photo analysis was 1,041. The collapsed  
143 buildings identified from the photo analysis mostly correspond to the D5 buildings (202 out

**Figure 8.** Distribution of damaged buildings detected from the field survey conducted in June 2016. Colors show the damage level.

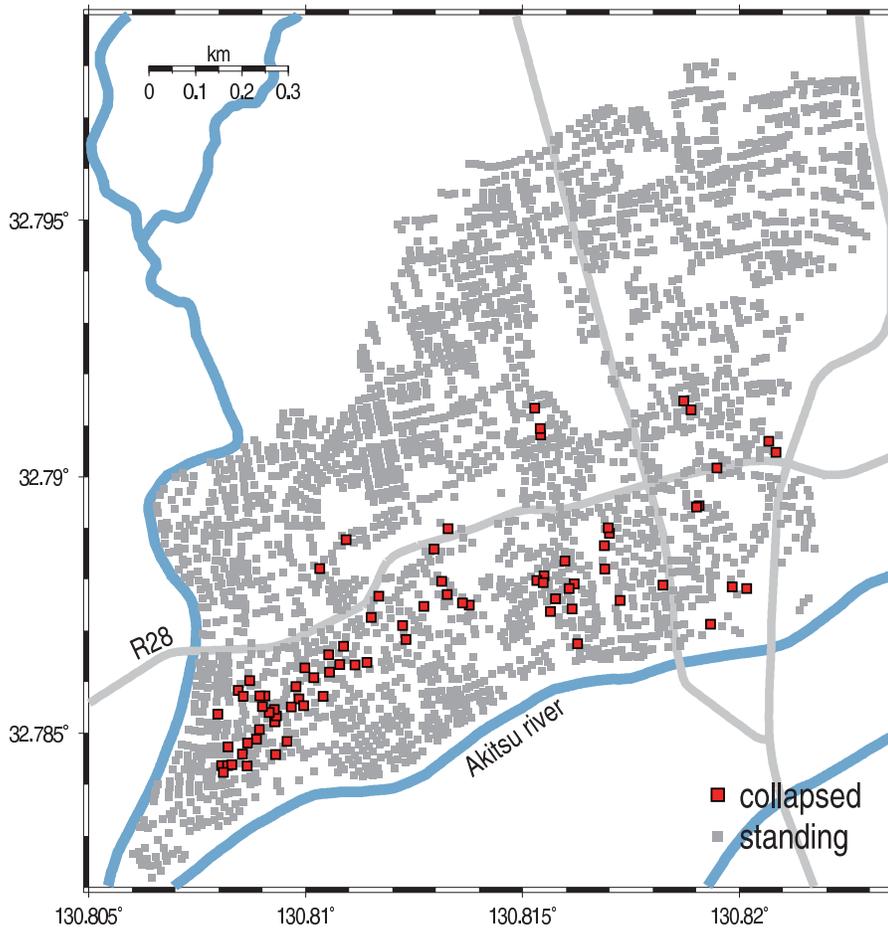
**Figure 9.** Distribution of collapsed buildings detected from the aerial photo analysis before the April 16 event.

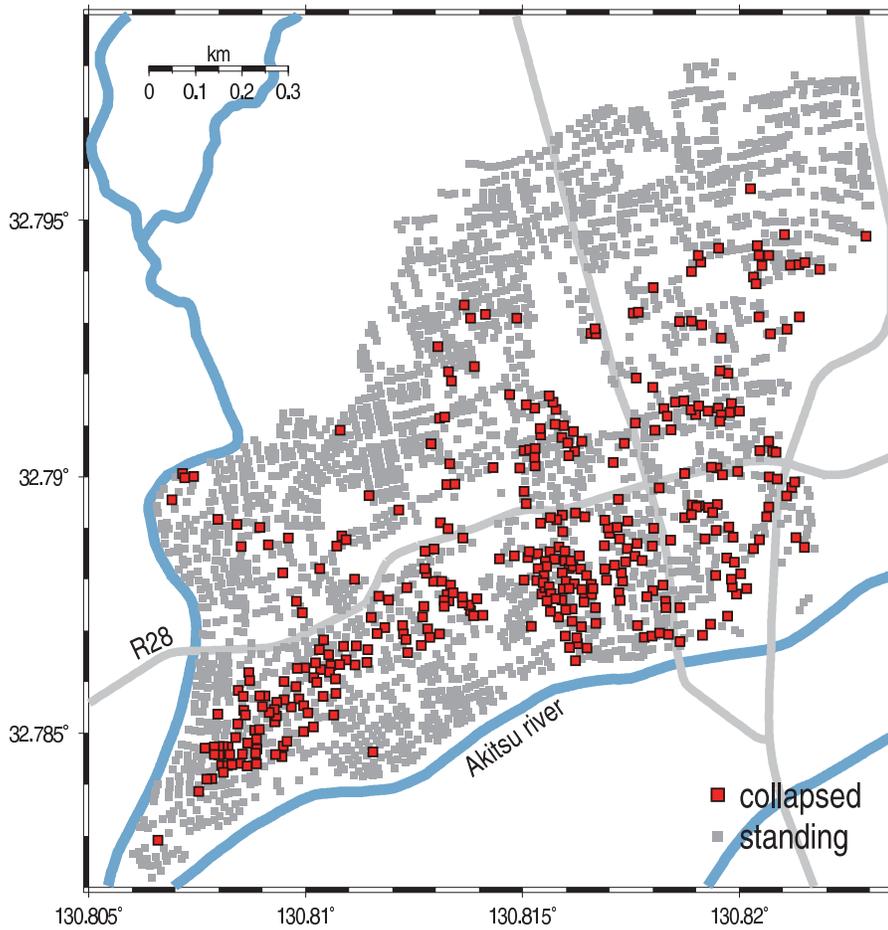
**Figure 10.** Distribution of collapsed buildings detected from the aerial photo analysis after the April 16 event.

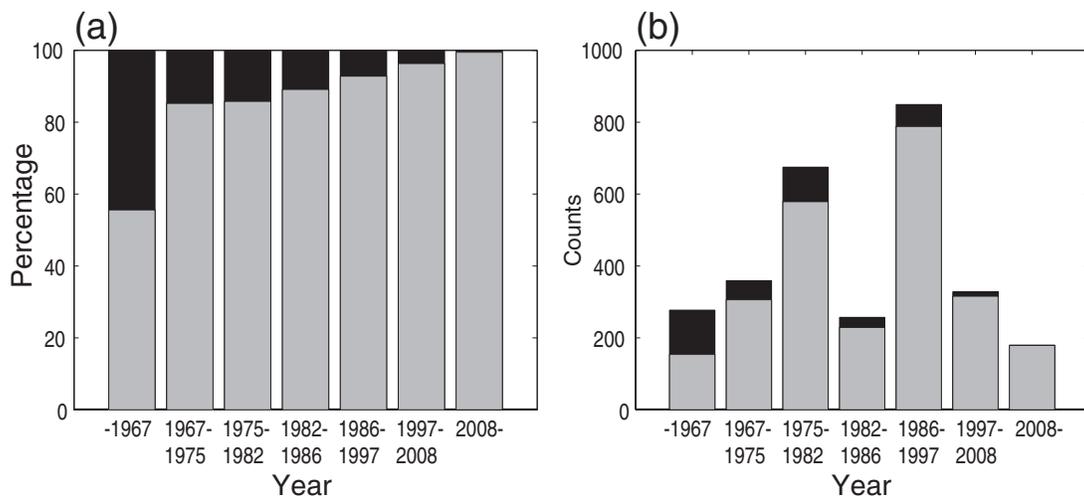
159 Figure 11(a) shows the percentage of collapsed buildings according to different construction  
160 periods. The damage distribution identified from the aerial photo is used for this analysis. The  
161 age was estimated using the previous aerial photos, and the distribution in age of the buildings is  
162 shown in Figure 12. Figure 11(a) shows that there was a strong correlation between the building  
163 age and the collapse ratio, and that the older buildings had higher collapse ratios. The buildings  
164 over 50 years old had a very high collapse ratio of 40%. The number of buildings analyzed  
165 for the different periods is shown in Figure 11(b). The figure shows that many buildings were  
166 constructed in the 1970s and 1980s, but that new buildings have been continually constructed,  
167 even during the last 10 years.

201 is observed to have an effect on the damage distribution (Figure 11), but cannot completely  
202 explain all of the observed aspects in Figure 13. The figure shows that the heterogeneity exists  
203 even when the buildings are of similar age.

**Figure 11.** (a) Percentage and (b) number of collapsed buildings (black) and standing buildings (gray) for different building construction periods.

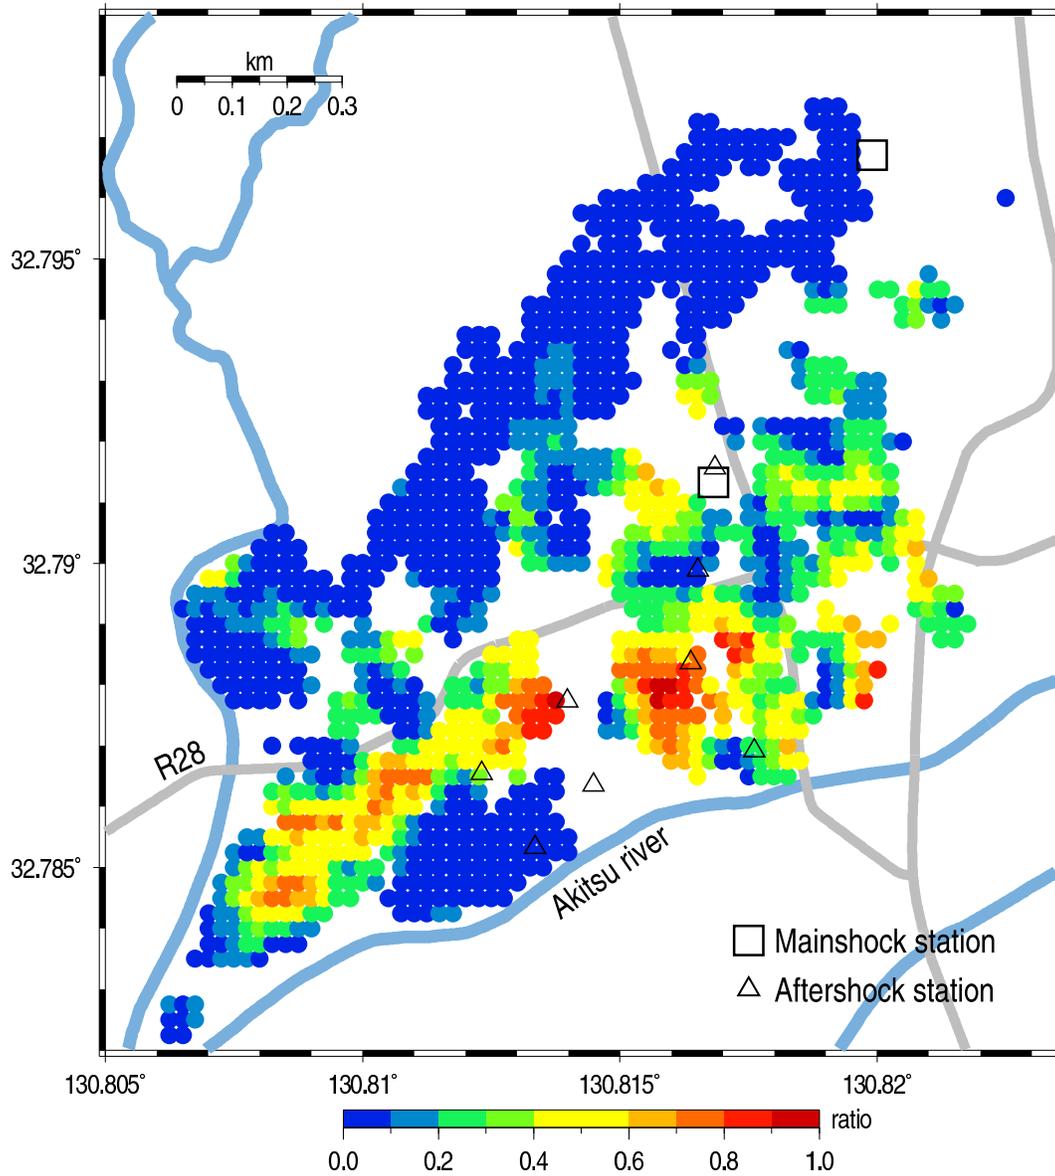
168 Since the percentages of damaged buildings constructed between 1967 and 1986 were sim-  
169 ilar, we focused on the buildings constructed during this period to minimize the effect of the  
170 building age. Figure 13 shows the ratio of the collapsed buildings only for buildings constructed  
171 between 1967 and 1986. Note that only the grid points with more than five buildings are shown  
172 in the figure. The distribution is very similar to Figure 7, which suggests that the damage dis-  
173 tribution was caused not only by the age of the buildings, but also by other local conditions.

**Figure 13.** Ratio of collapsed buildings that were constructed between 1967 and 1986, detected from the aerial photo analysis after the April 16 event.

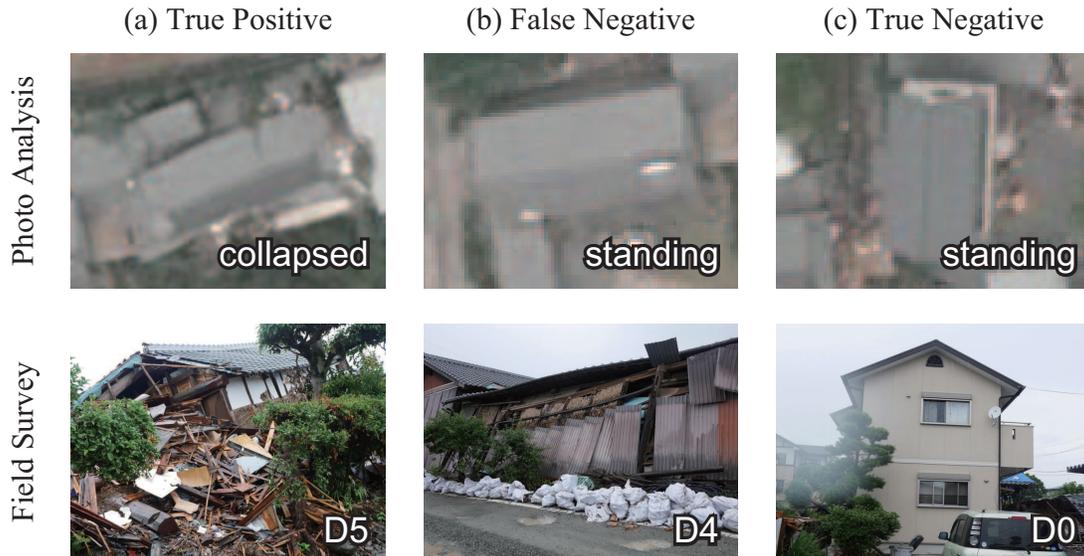
144 of 233 detections, 87%). However, there were a significant number of damaged buildings not  
145 detected from the aerial photos (79 buildings), or falsely determined as damaged (31 buildings).  
146 In general, D4 and D5 buildings are classified as totally collapsed buildings in the damage  
147 survey (Okada and Takai, 2000). Using this definition, there should have been 439 totally  
148 collapsed buildings (158 of D4 and 281 of D5), however, only 233 totally collapsed buildings  
149 were identified by the photo analysis. We checked the buildings that were classified as fully  
150 collapsed in our photo analysis but that were classified as D1–D3 (partially collapsed) in the  
151 field survey. Seven of these had serious damage to their roofs, which caused us to classify them  
152 as fully collapsed in the photo analysis. In addition, two of these were not accessible from the  
153 public road, so in the field survey the damage condition was determined from only one side of

154 the buildings. The aerial photo showed substantial debris around the buildings, which suggested  
155 that the actual damage condition might have been more serious than that determined by the field  
156 survey. Therefore, one of the advantages of photo analysis is that certain aspects of building  
157 damage can be detected, which could not be seen in the field survey.

**Figure 15.** Examples of the (a) true positive, (b) false negative, and (c) true negative of the damage level from the photo analysis and field survey.
