# <sup>1</sup> Building Damage Survey and Microtremor Measurements for the

# <sup>2</sup> Source Region of the 2015 Gorkha, Nepal Earthquake

Preprint submitted to Earth, Planets and Space on May 31, 2016

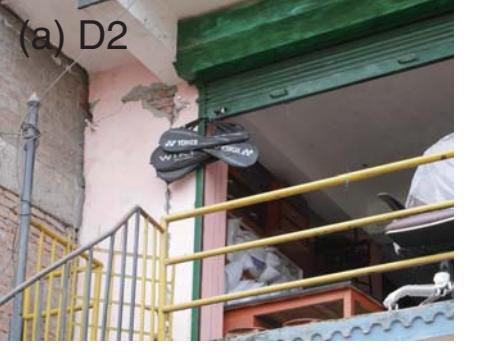
- Figure 4. Photo of buildings with damage levels D2-D4. (a) D2: plasters on the column was fallen down.(b) D3: permanent drift was observed. (c) D4: almost all infil was fallen down.
