# 2019年山形沖の地震の 被害調査報告

Damage survey report  
for the 2019 Yamagata earthquake

京都大学防災研究所  
山田真澄、Jim Mori、加茂正人

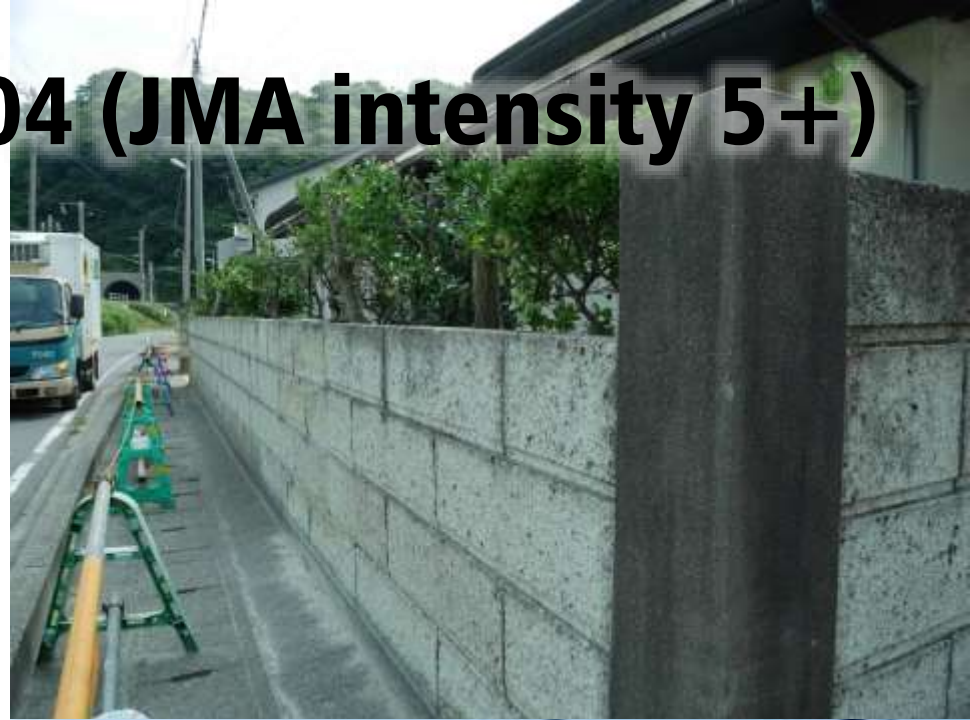
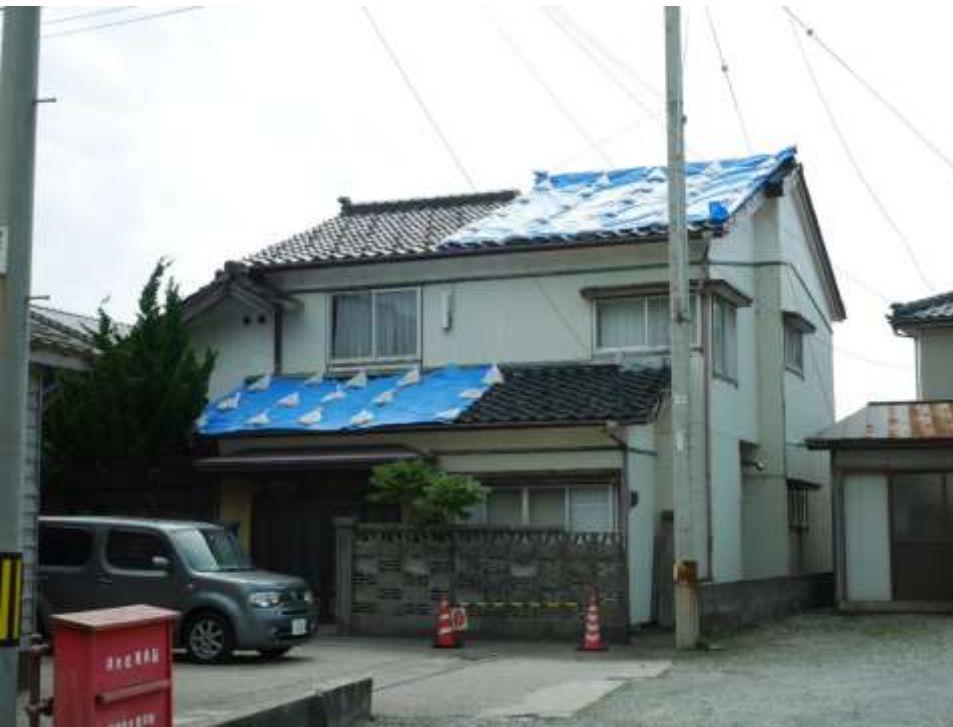
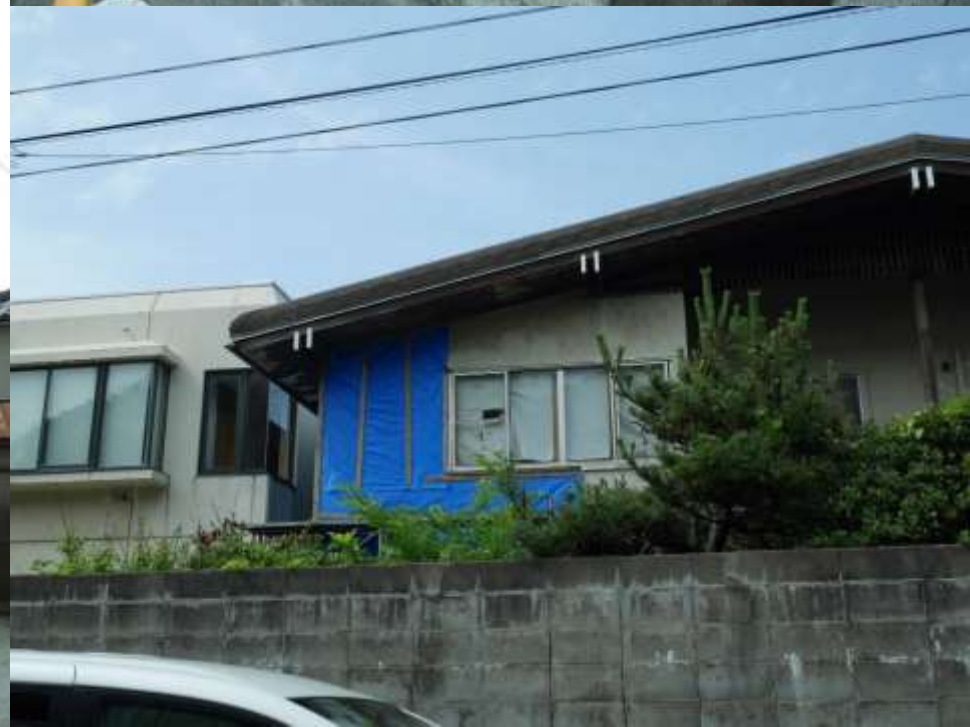
# 温海 | Atsumi, YMT004 (JMA intensity 5+)

- Fall of roof tiles (<5%)
- Collapse of block wall
- Fall of mortar wall

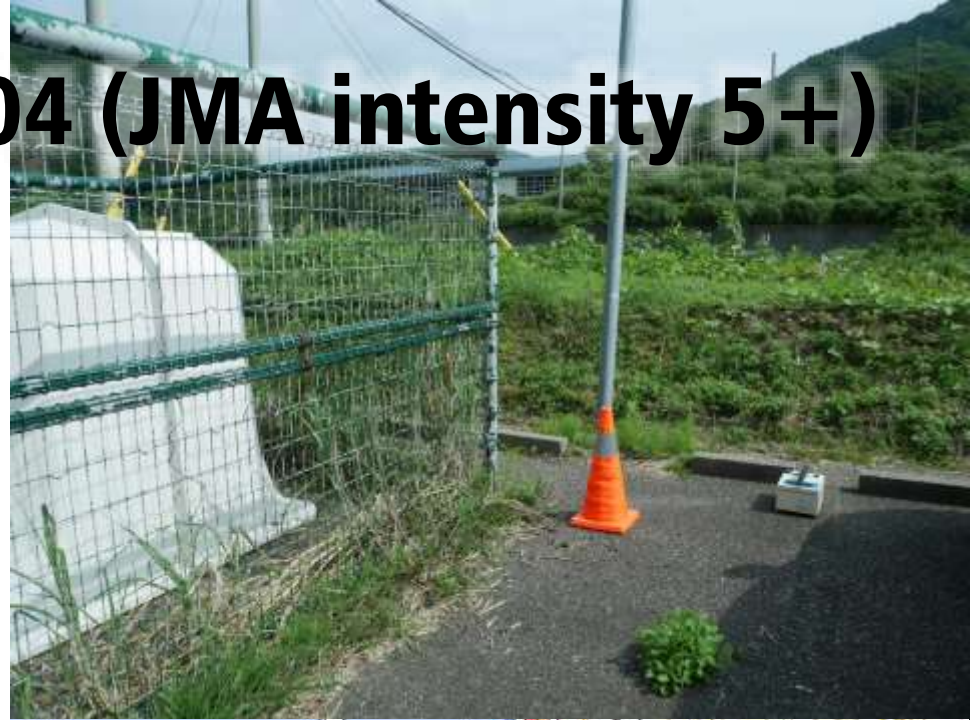
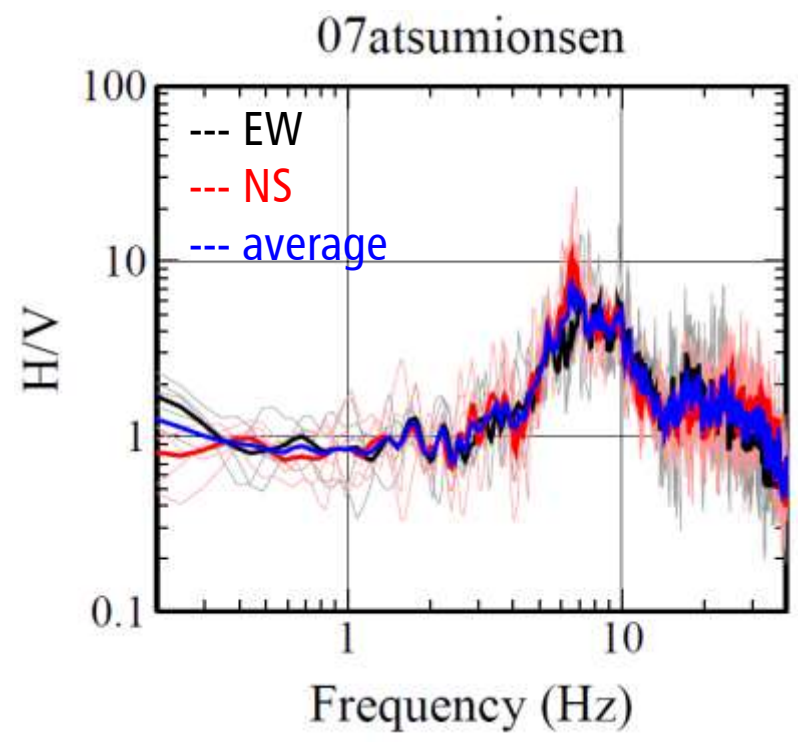
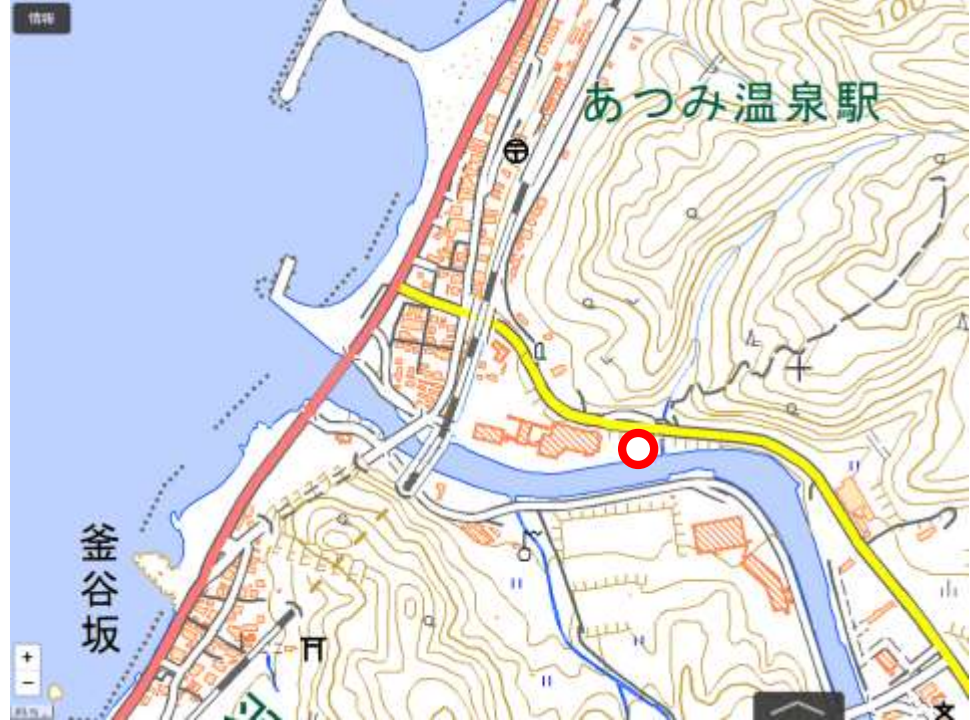
# 温海 | Atsumi, YMT004 (JMA intensity 5+)

Ambient noise measurement at the YMT004 station

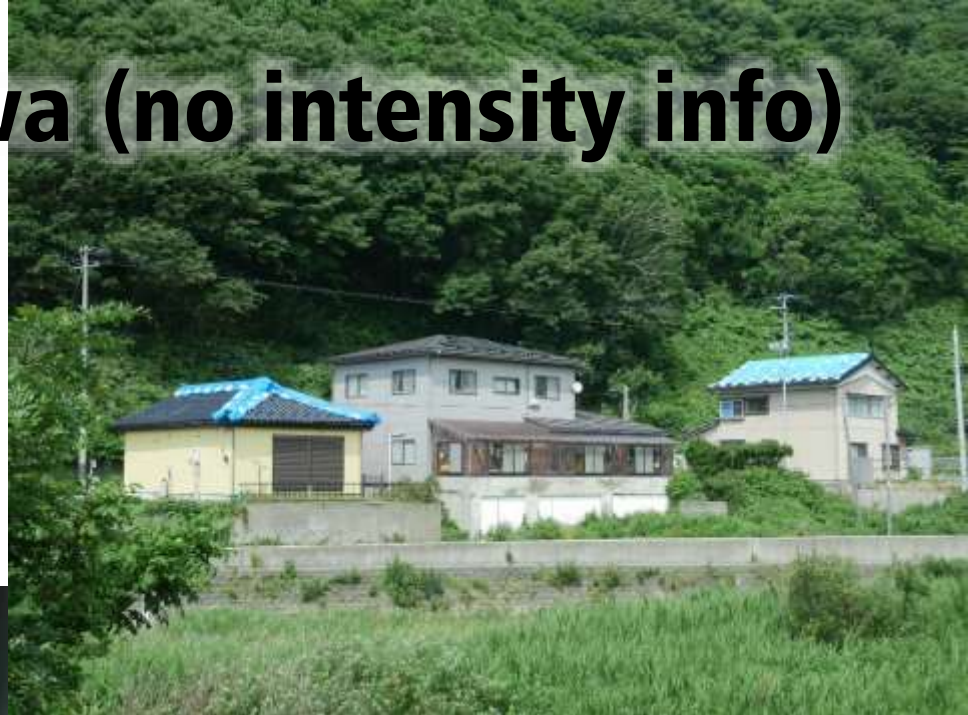
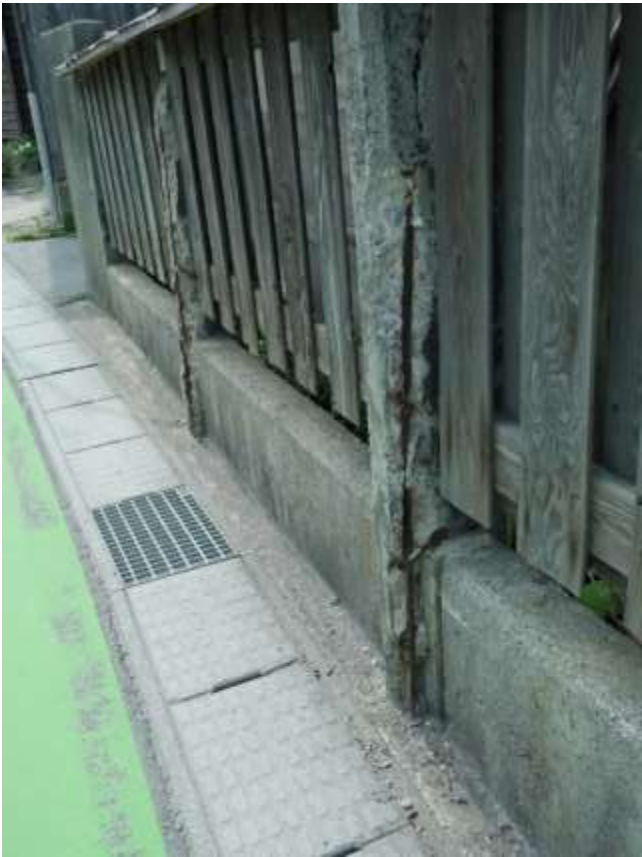
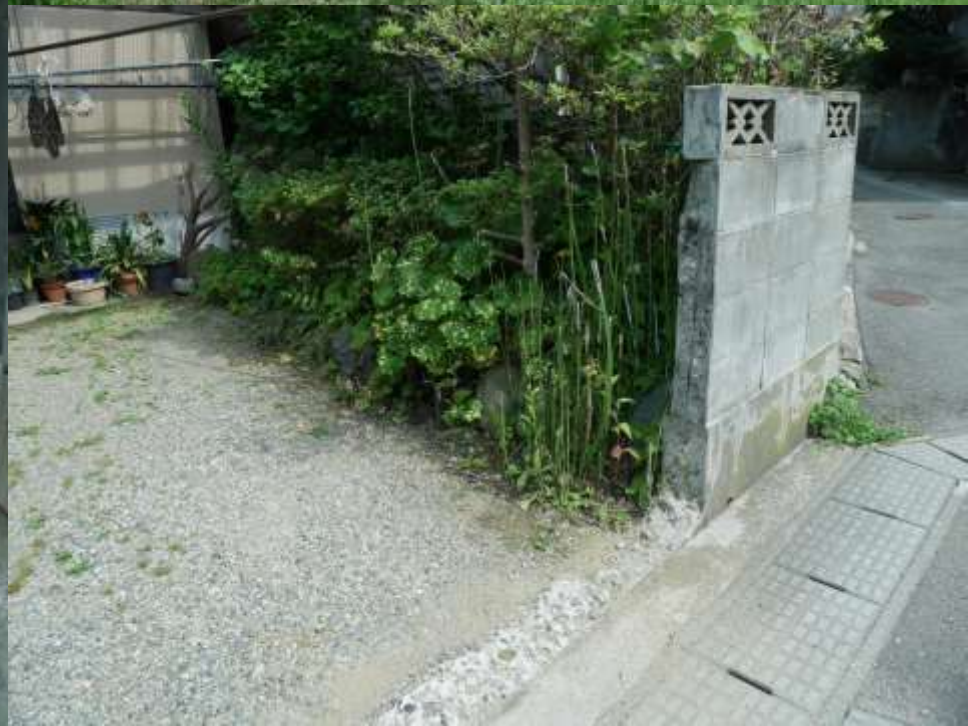
# 大岩川 | Ohiwagawa (no intensity info)

- Fall of roof tiles (<math>< 5\%</math>)
- Collapse of block wall
- Corrosion of reinforcement

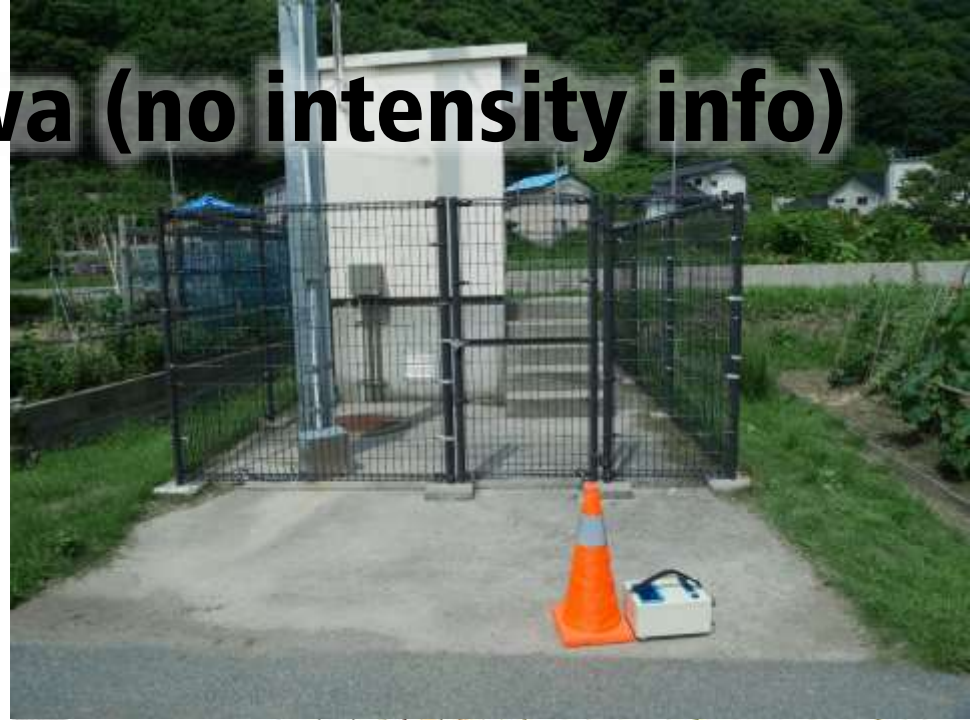
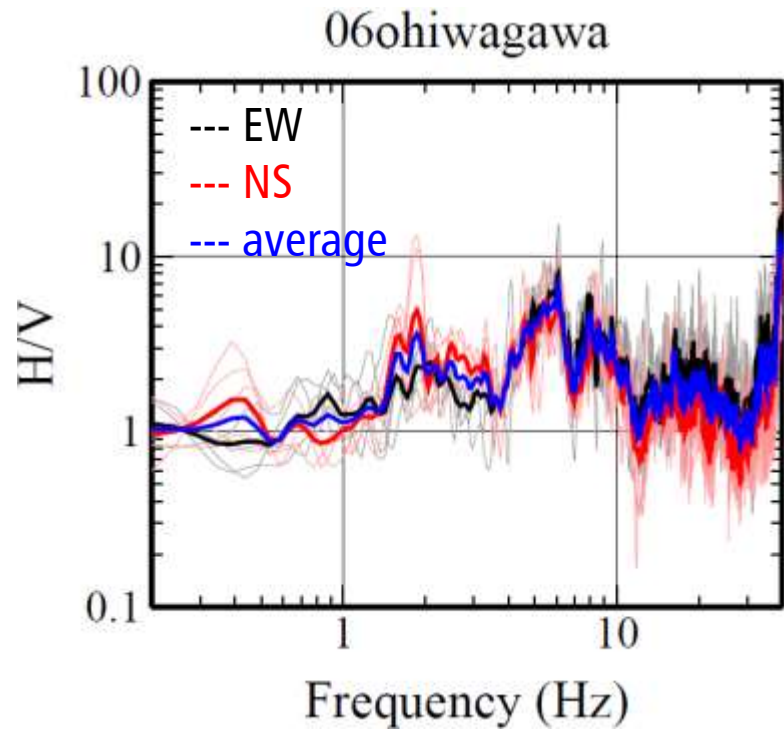
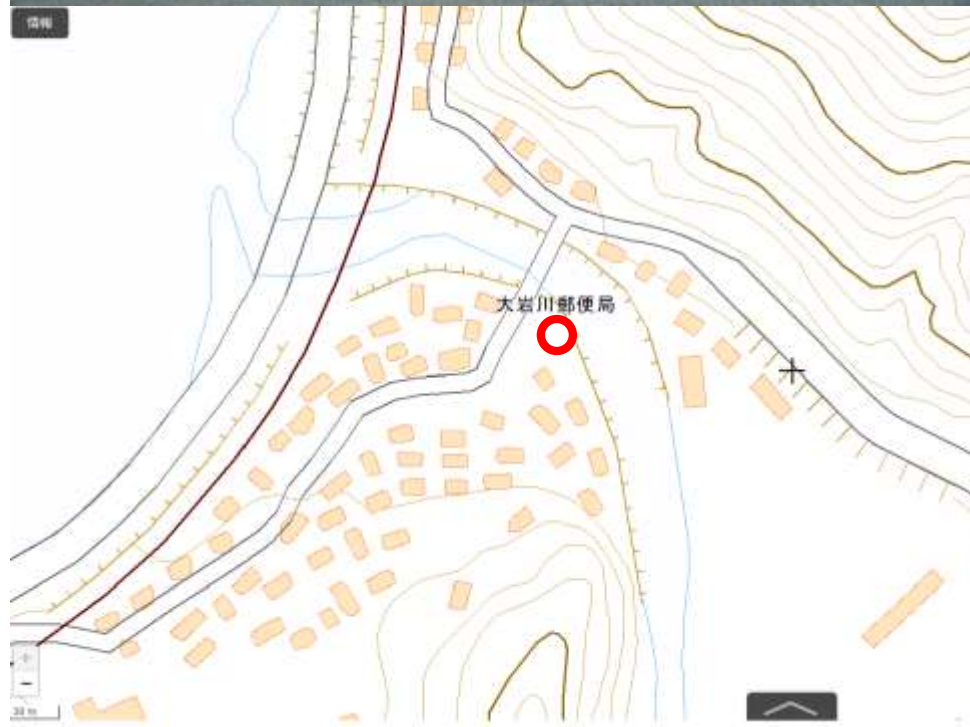
# 大岩川 | Ohiwagawa (no intensity info)

Ambient noise measurement near the post office

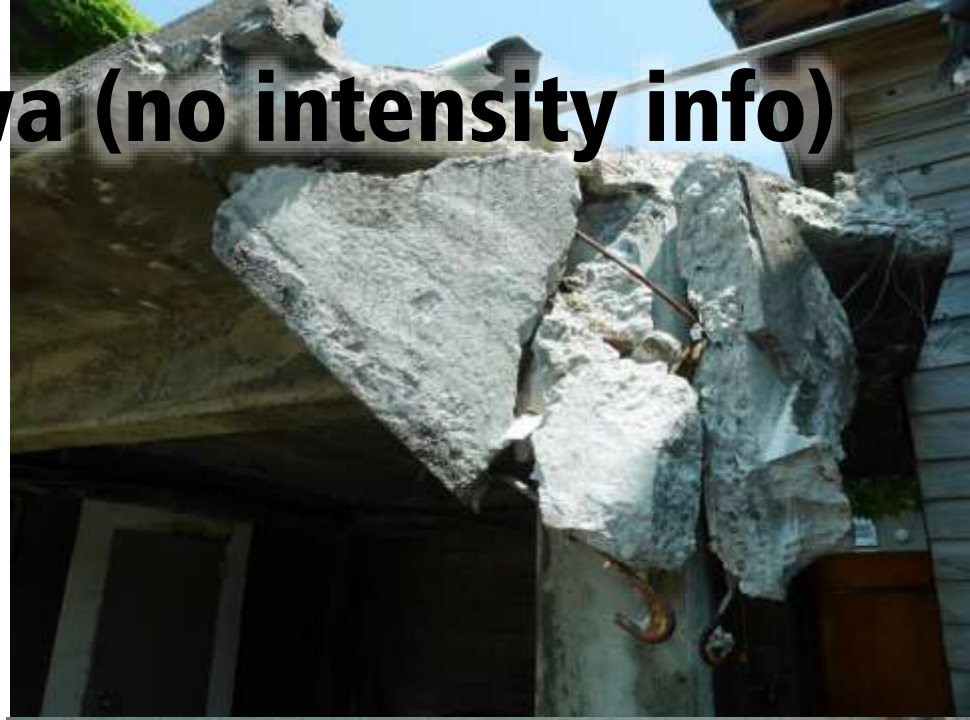
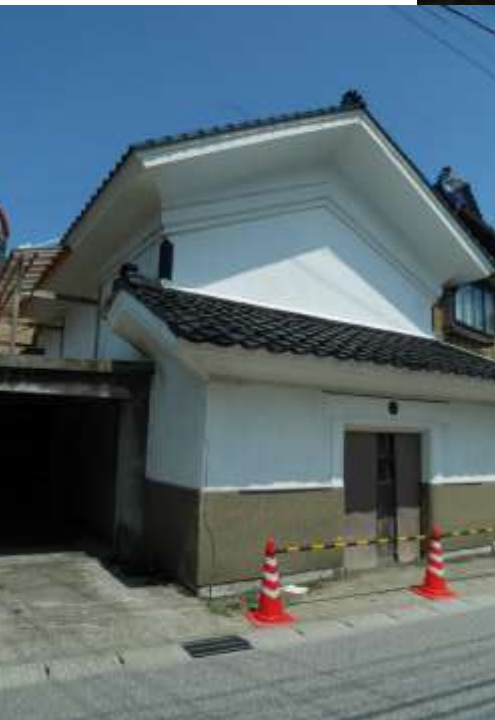
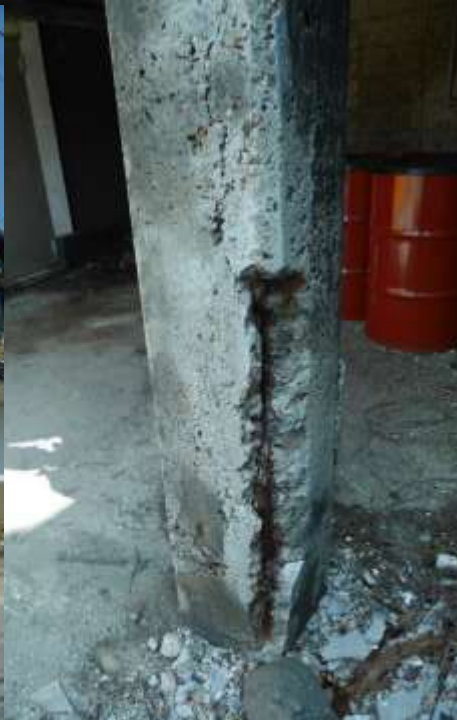
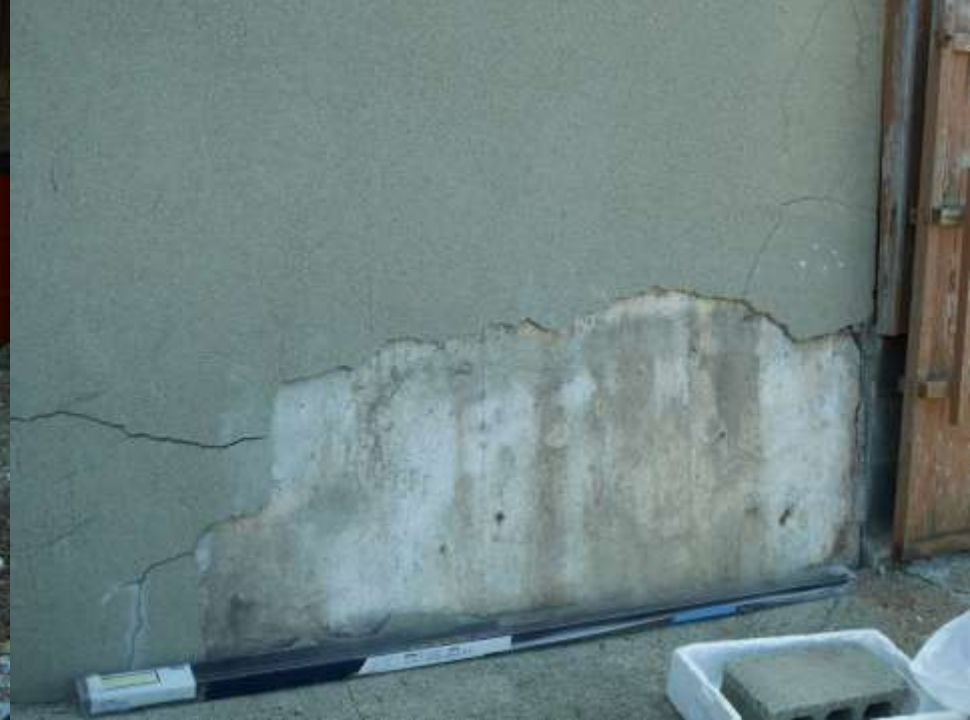
# 小岩川 | Koiwagawa (no intensity info)

- Fall of roof tiles (30%)
- Collapse of block wall
- Fall of mortar wall
- Tilt of old storage houses
- Corrosion of reinforcement

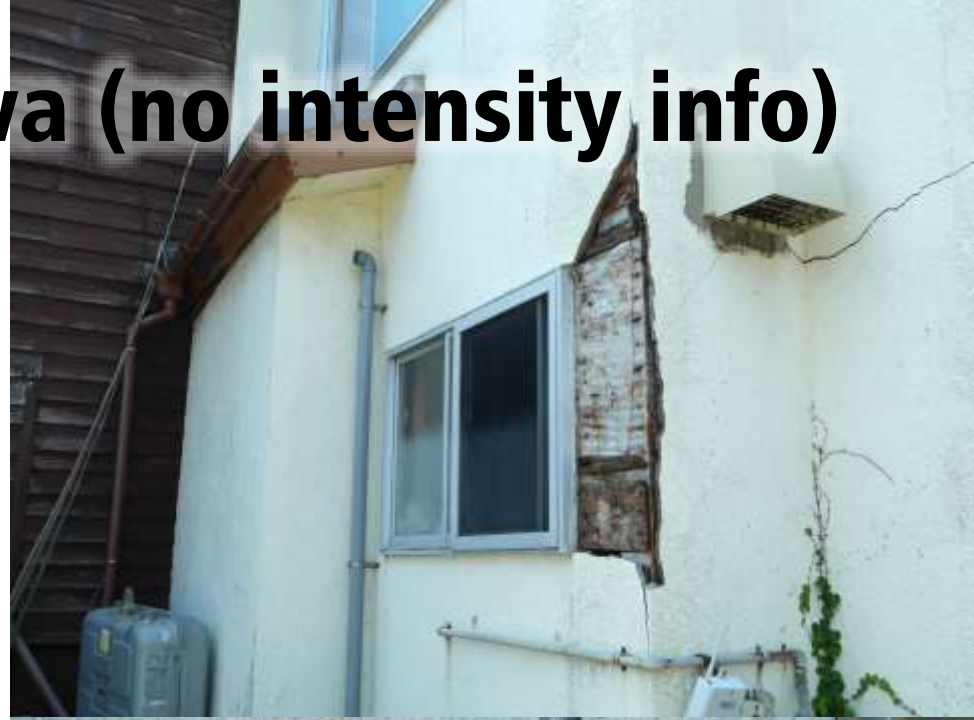
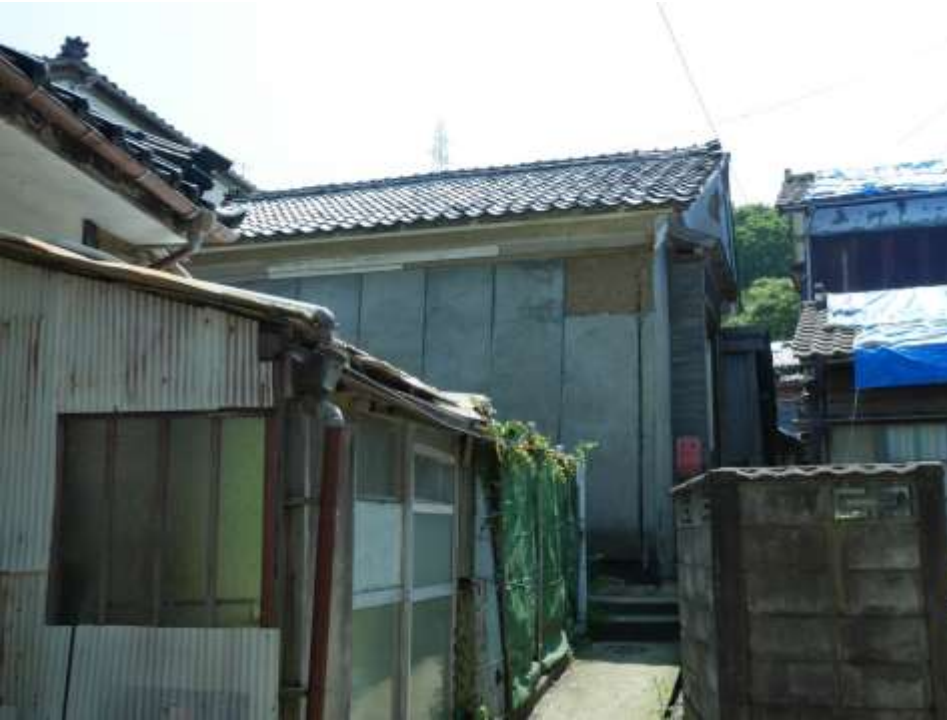
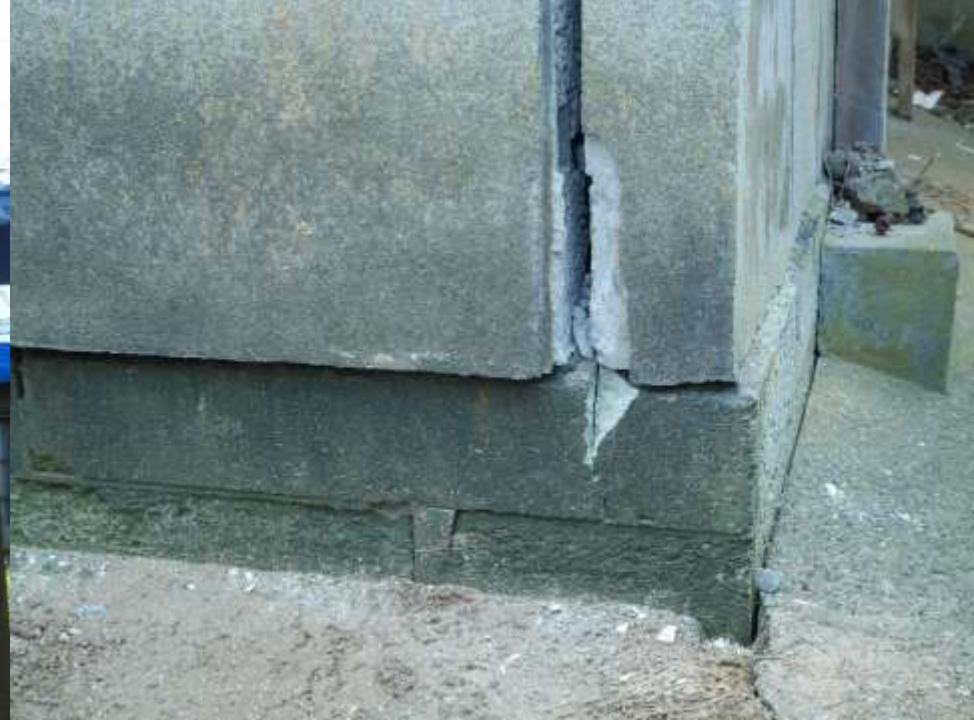
# 小岩川 | Koiwagawa (no intensity info)

- Fall of roof tiles (30%)
- Collapse of block wall
- Fall of mortar wall
- Tilt of old storage houses
- Corrosion of reinforcement

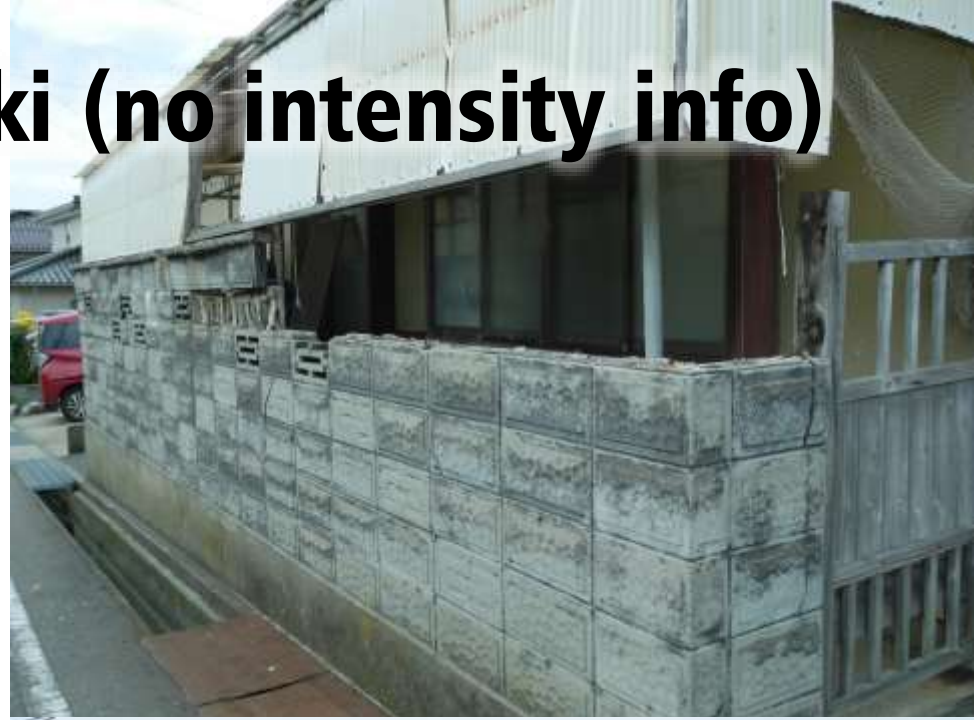
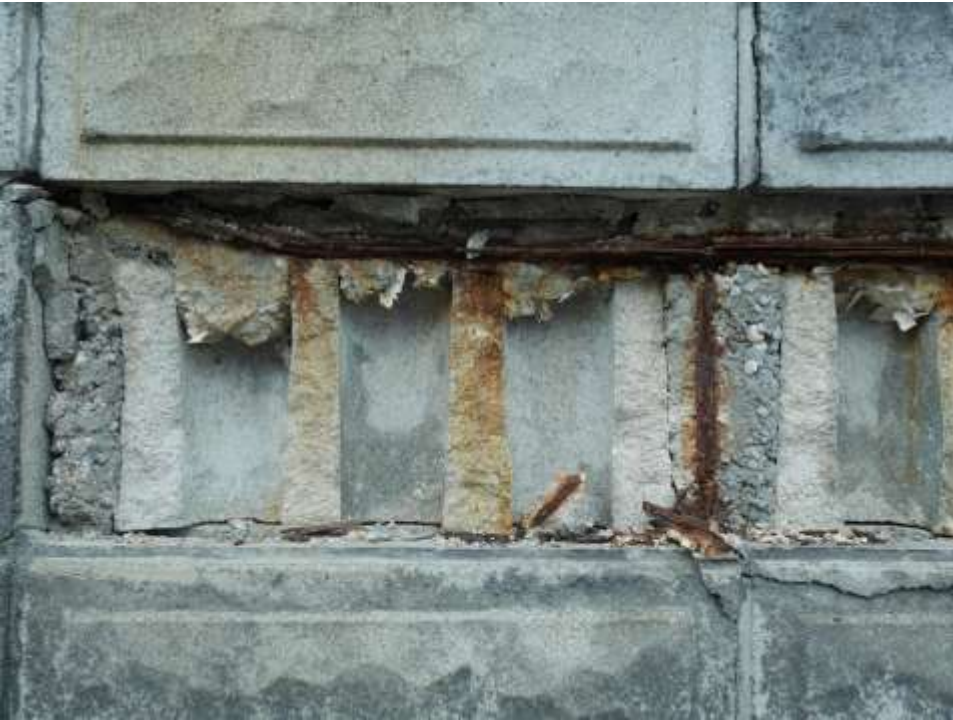
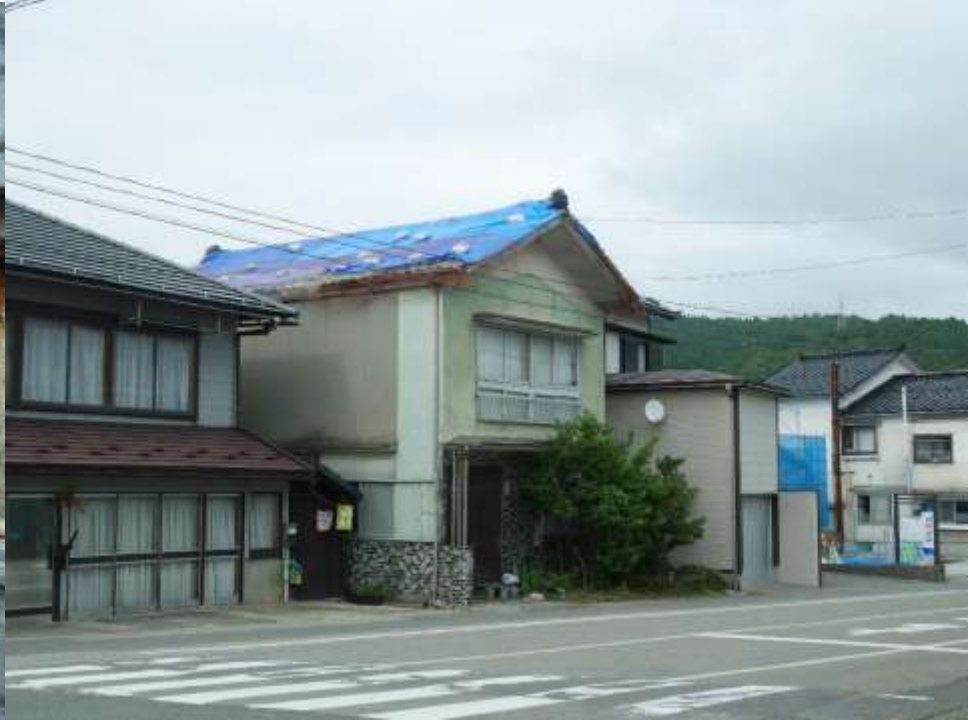
# 鼠ヶ関 | Nezugaseki (no intensity info)

- Fall of roof tiles (10%)
- Collapse of block wall
- Hair crack on the wall
- Corrosion of reinforcement

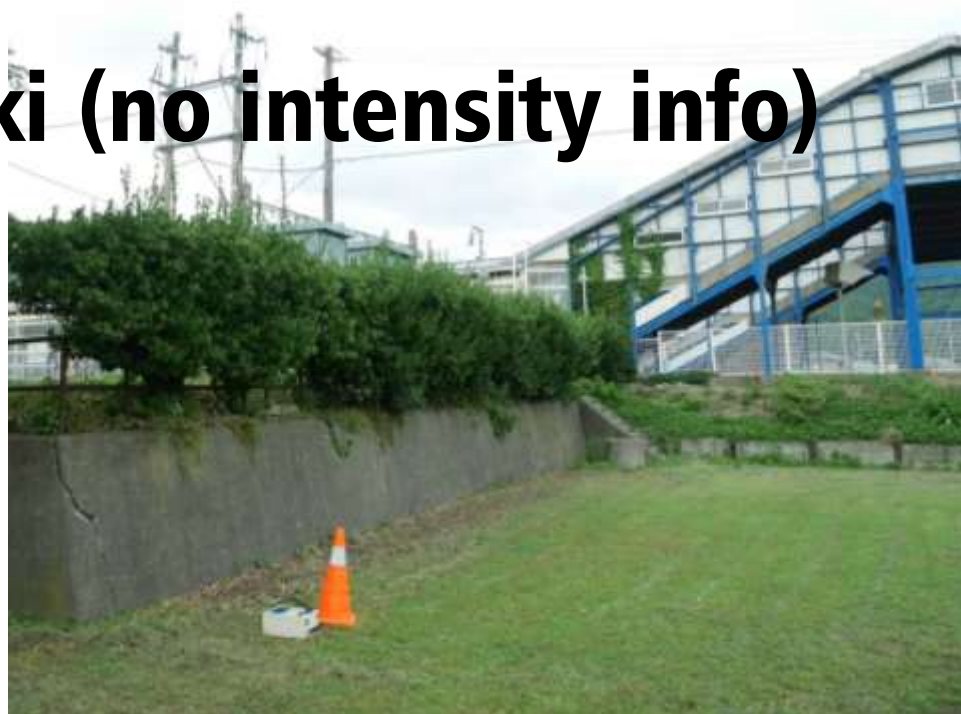
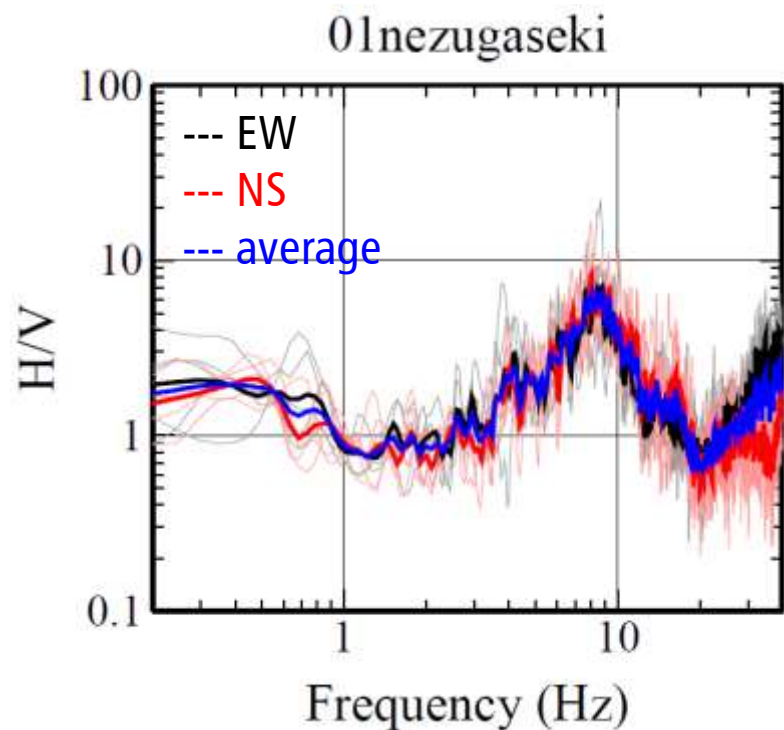
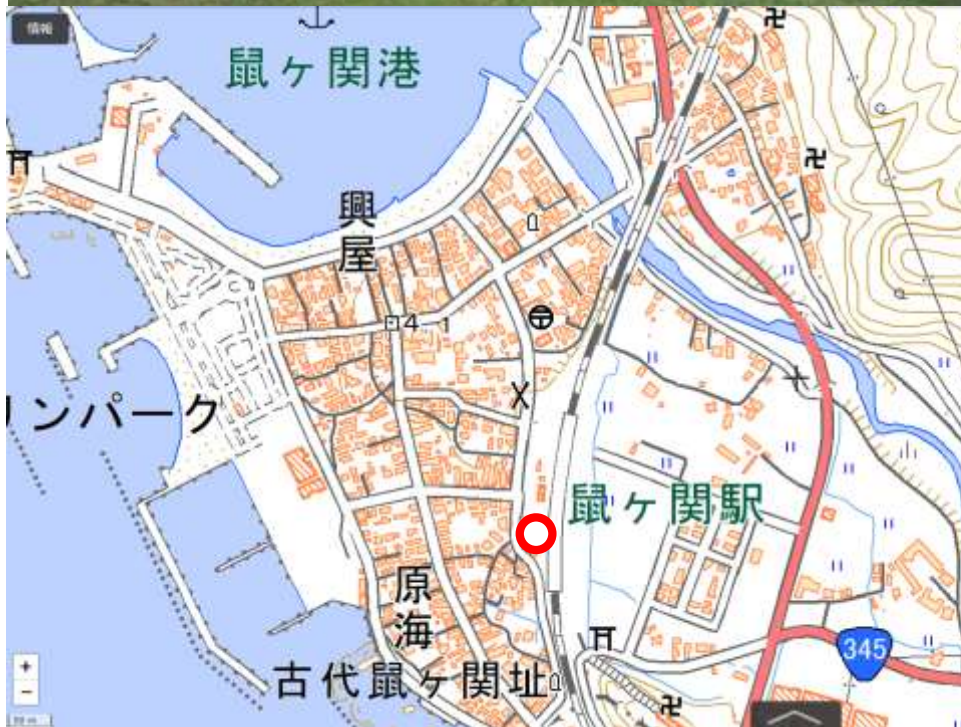
# 鼠ヶ関 | Nezugaseki (no intensity info)

Ambient noise measurement near the JR station

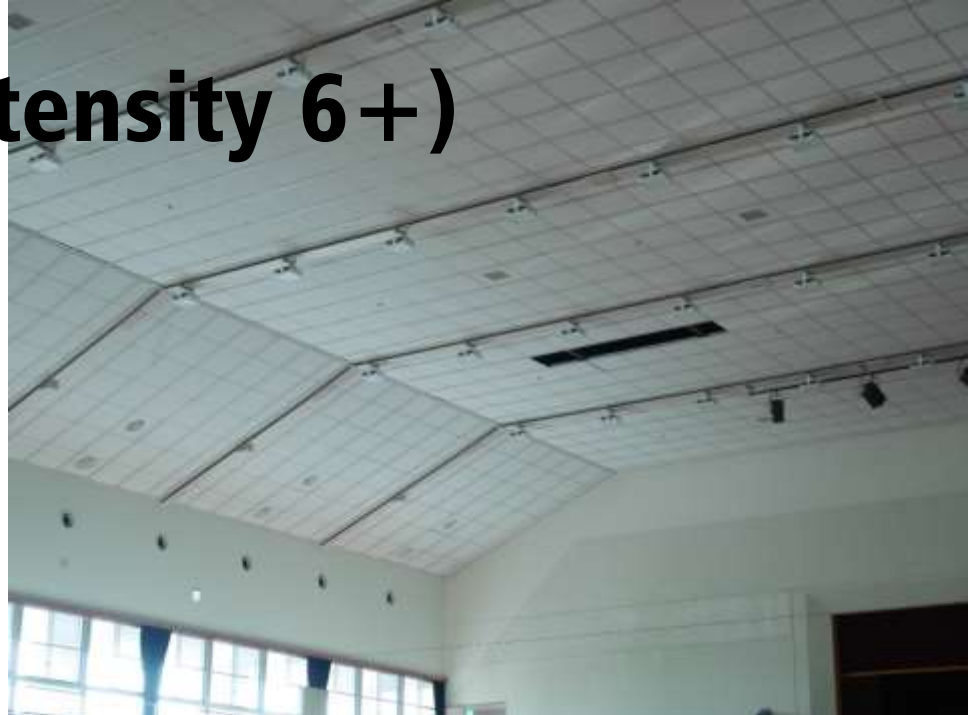
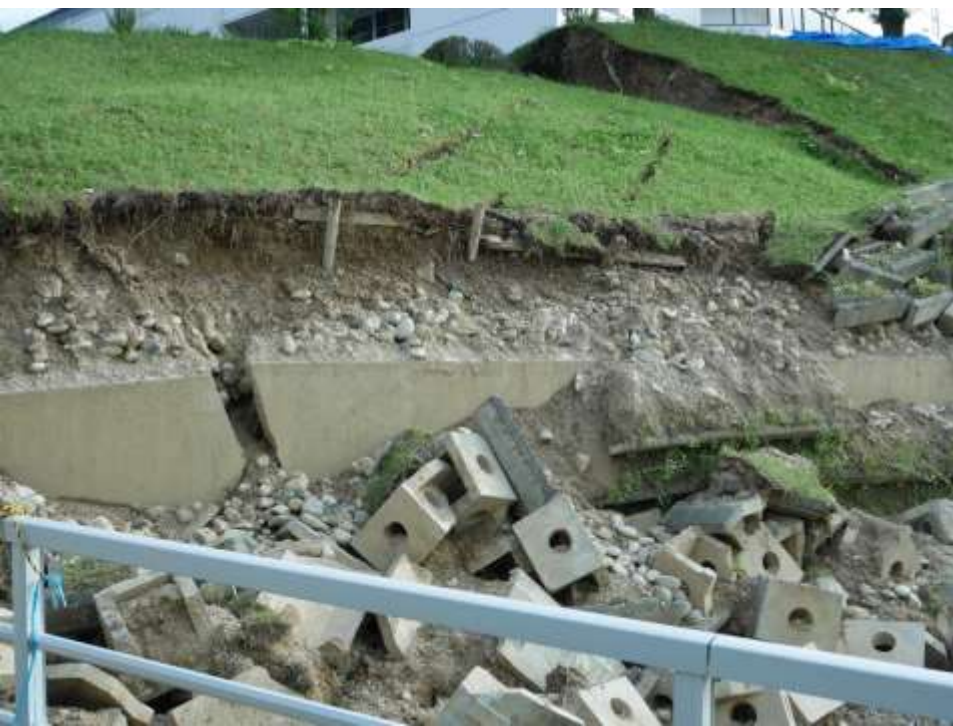
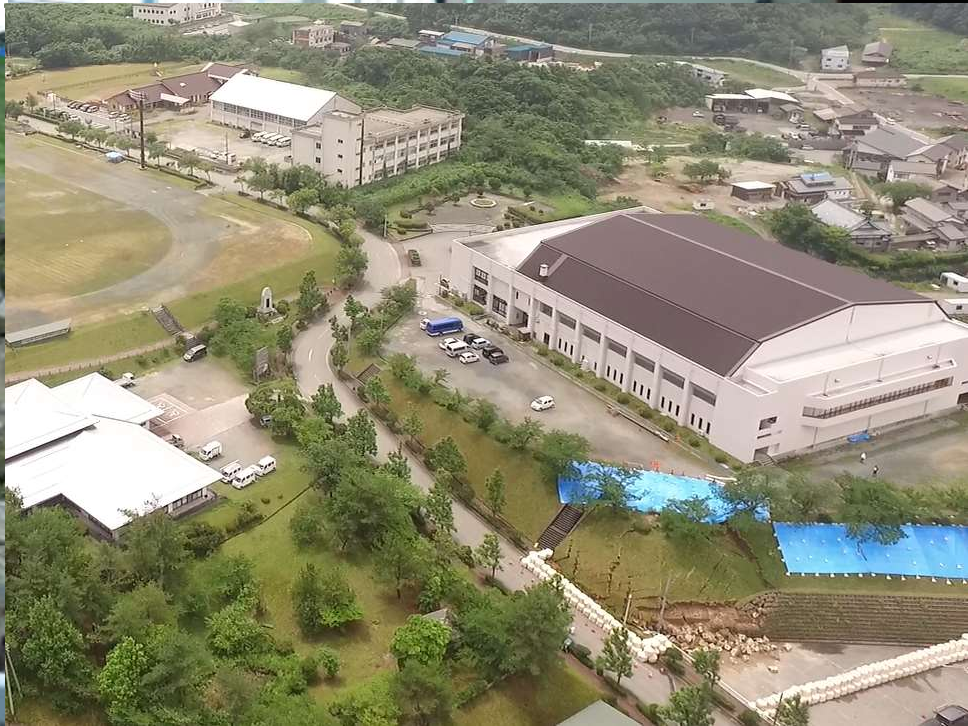
# 府屋 | Fuya (JMA intensity 6+)

- Fall of roof tiles (<5%)
- Fall of the ceiling of the gym
- Collapse of the embankment of the gym

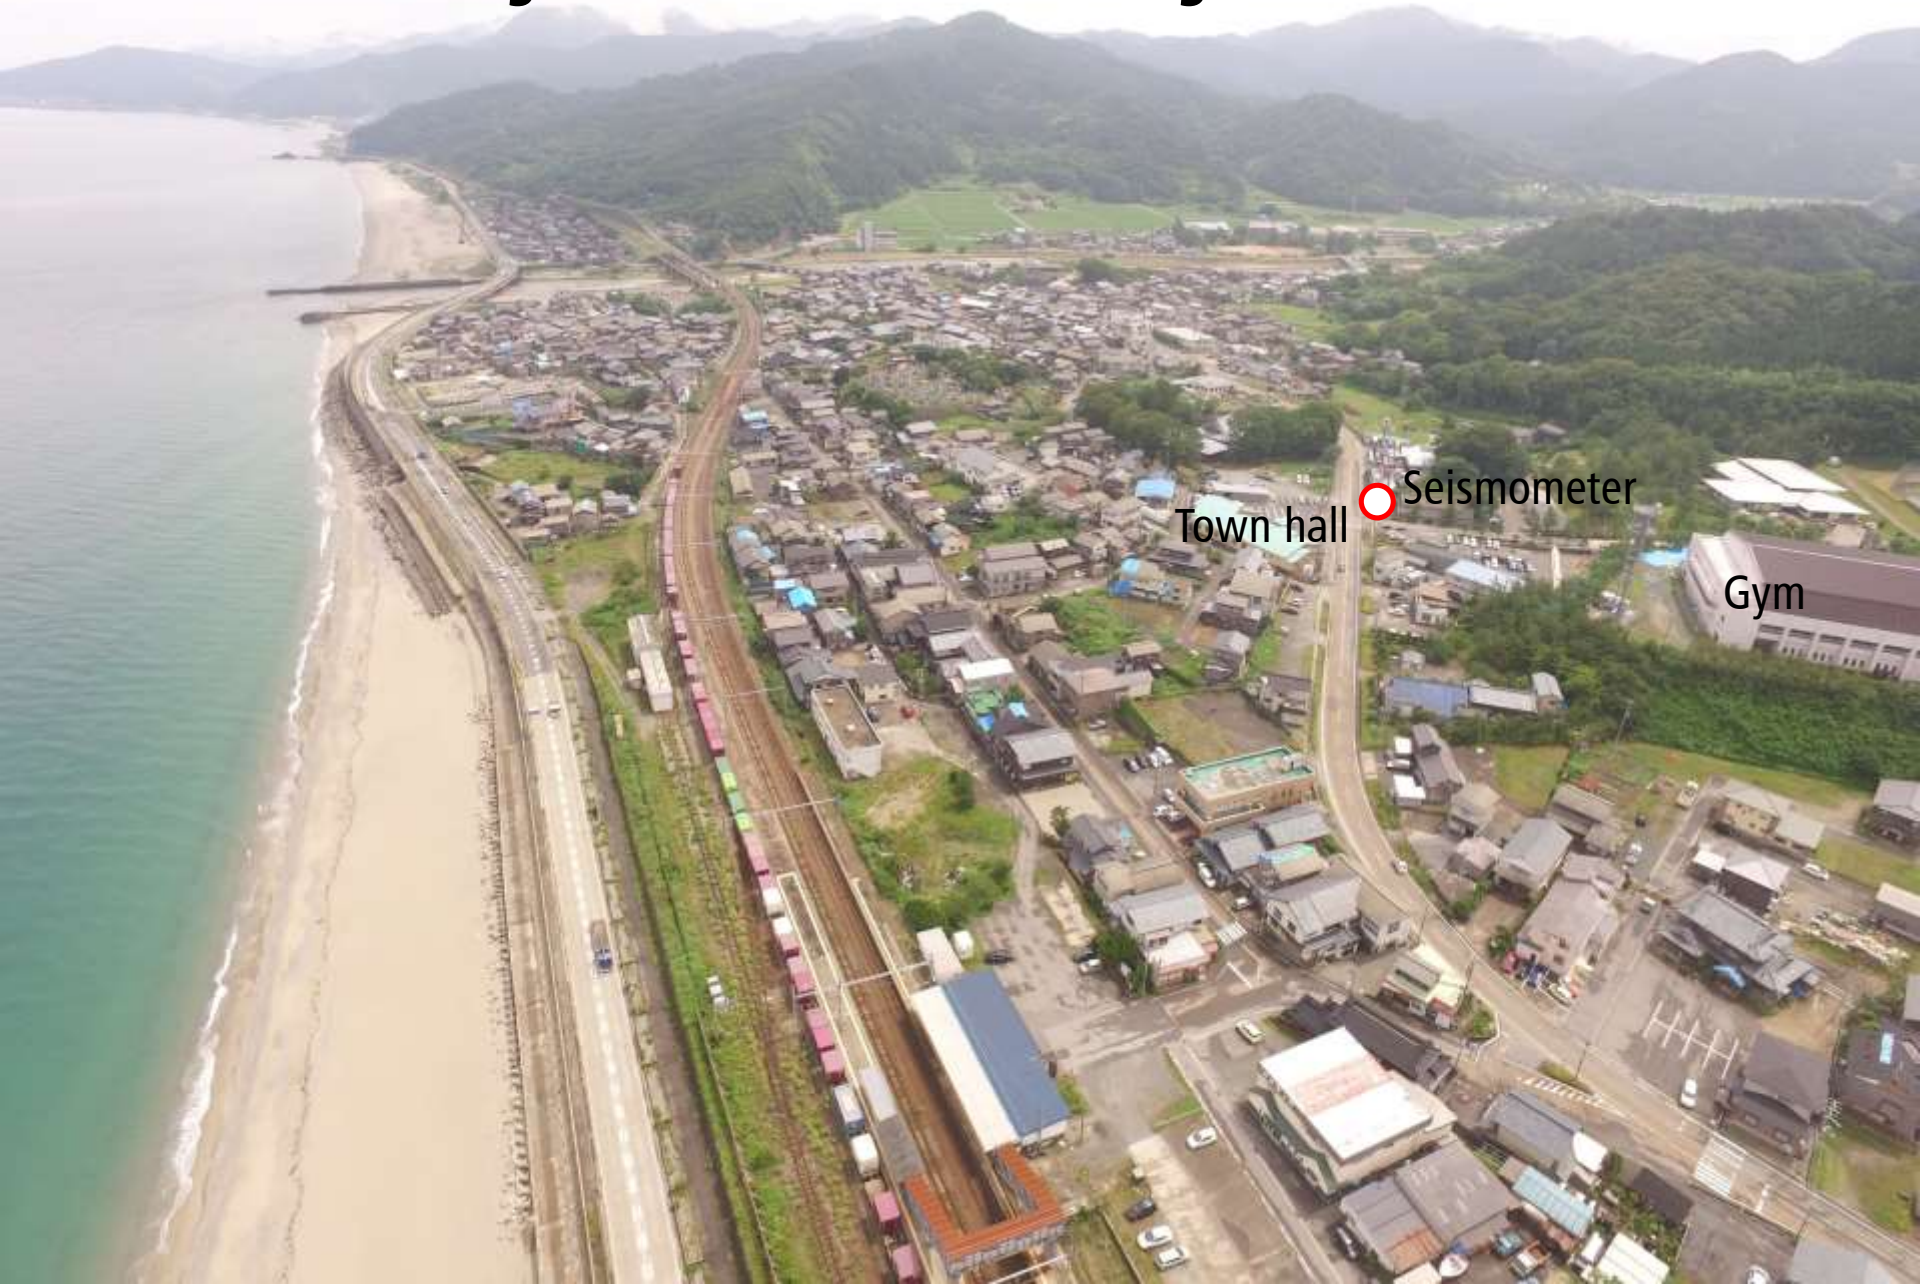
# 府屋 | Fuya (JMA intensity 6+)

Town hall

Seismometer

Gym

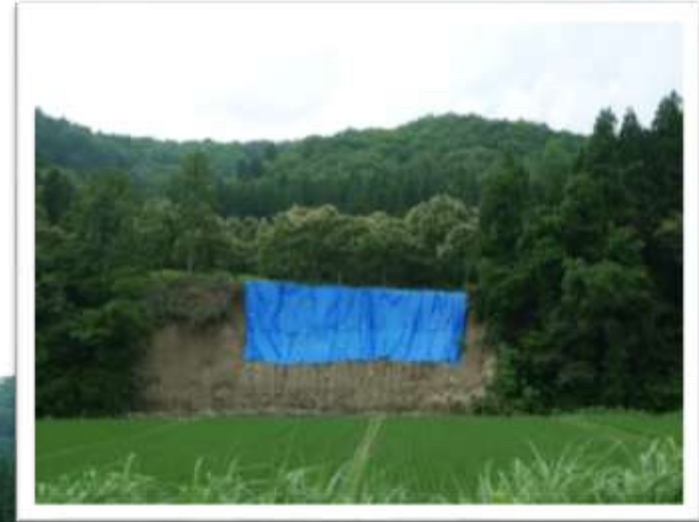
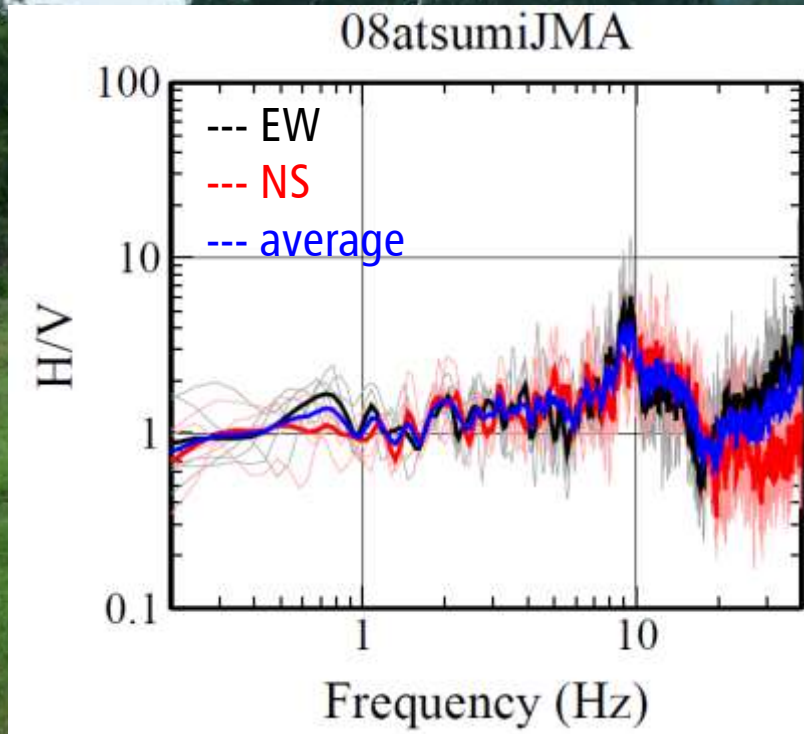
# 温海川 | Atusumigawa (JMA intensity 6-)

- Middle of large field
- Small landslide nearby
- Very minor damage in nearby town
