# 2019年山形沖の地震の 被害調査報告

Damage survey report  
for the 2019 Yamagata earthquake

京都大学防災研究所  
山田真澄、Jim Mori、加茂正人

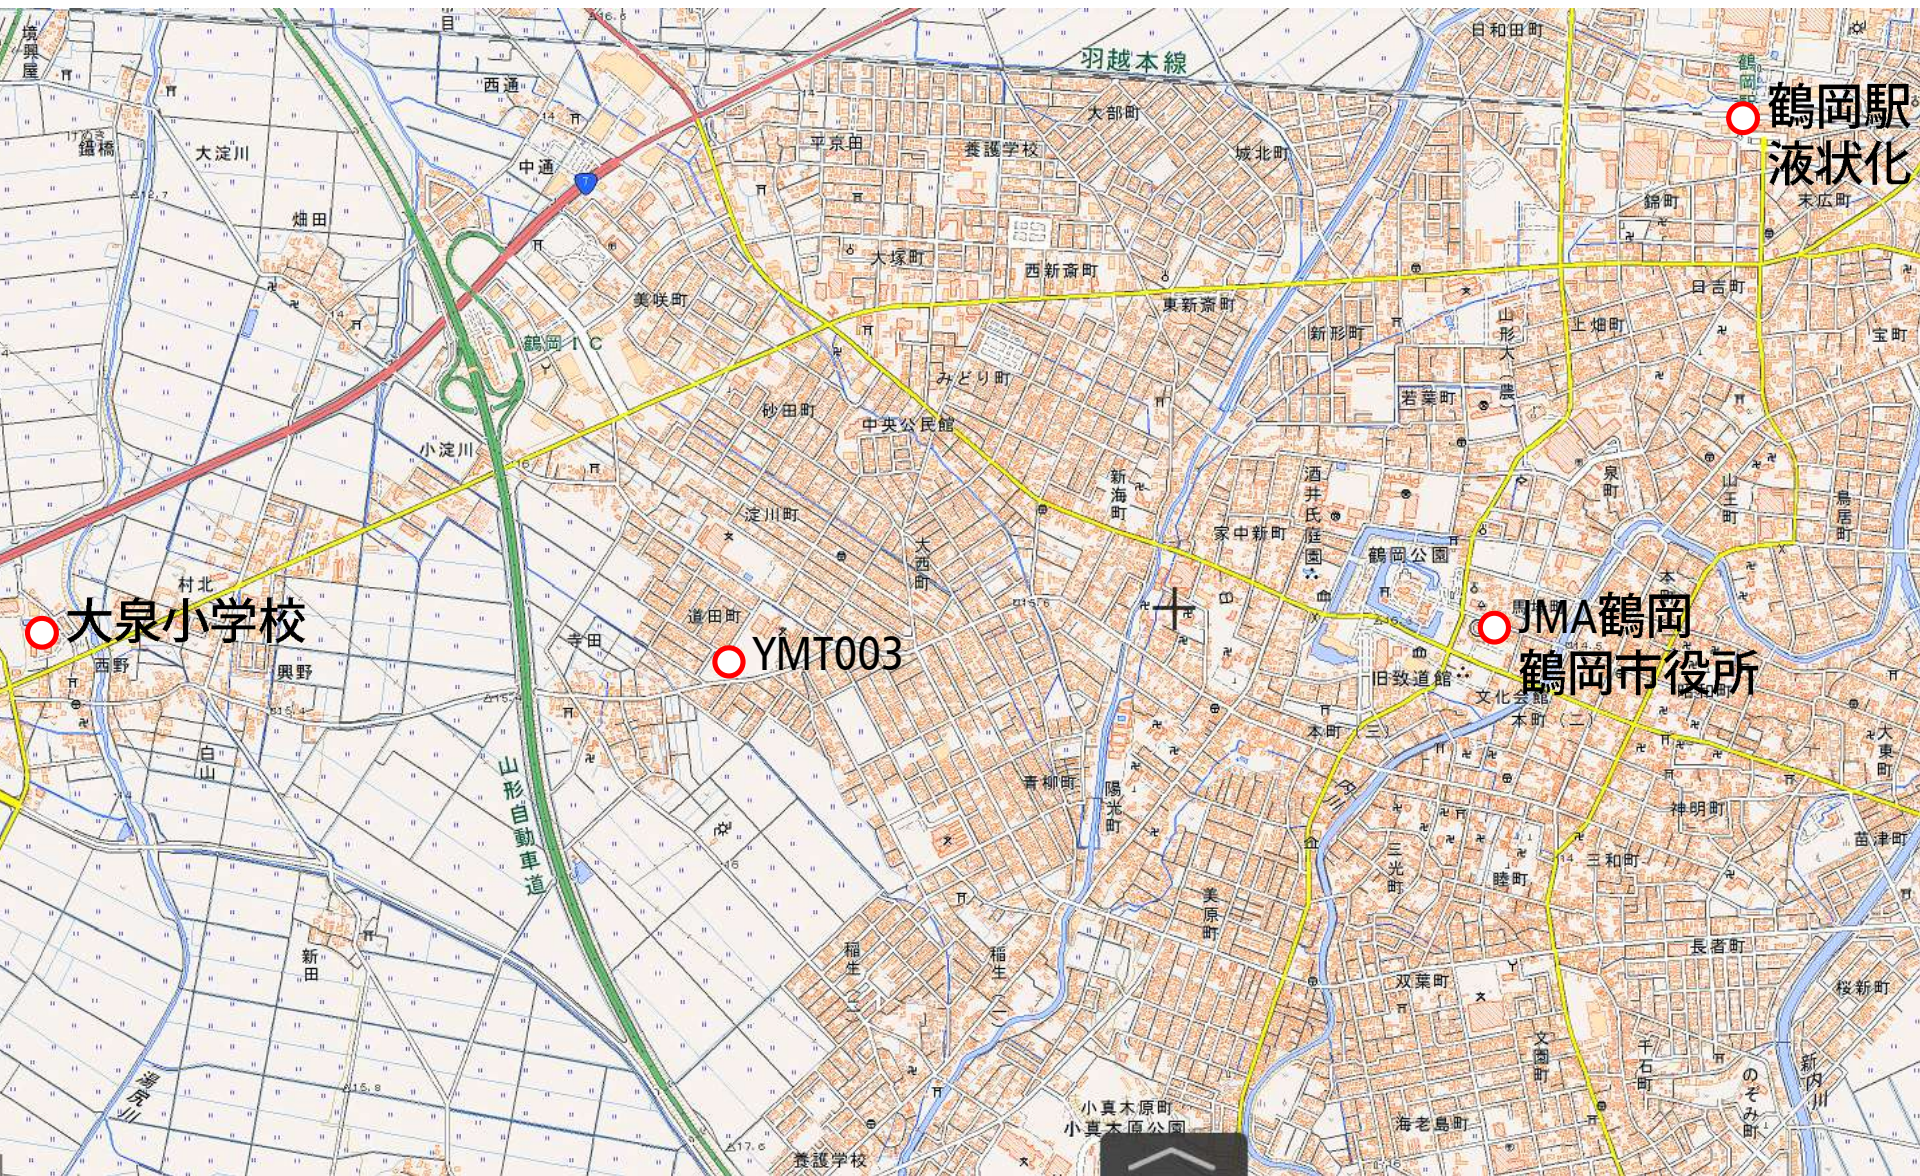
- Middle of large field
- Small landslide nearby
- Very minor damage in nearby town

Seismic station

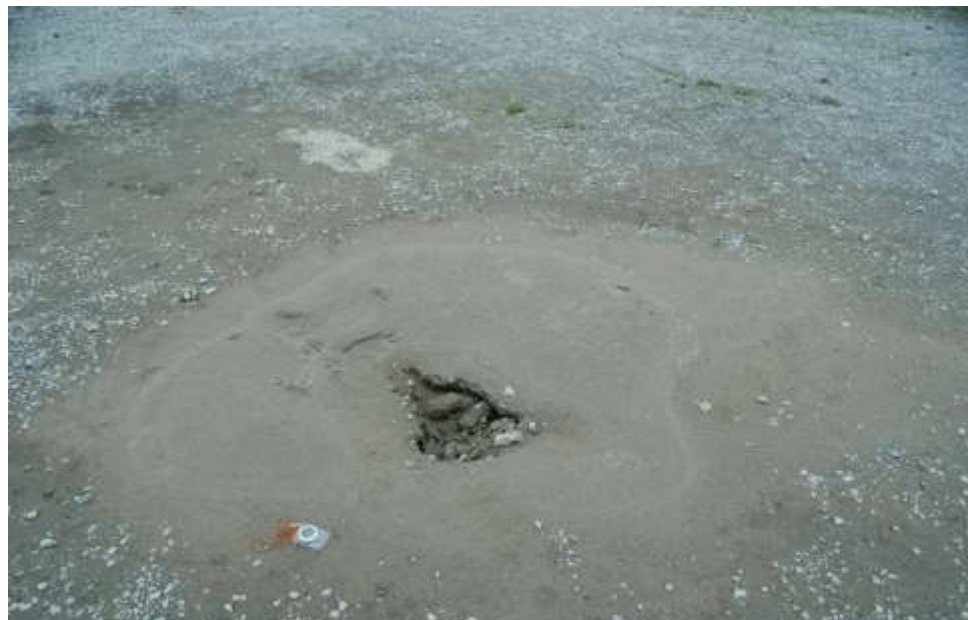
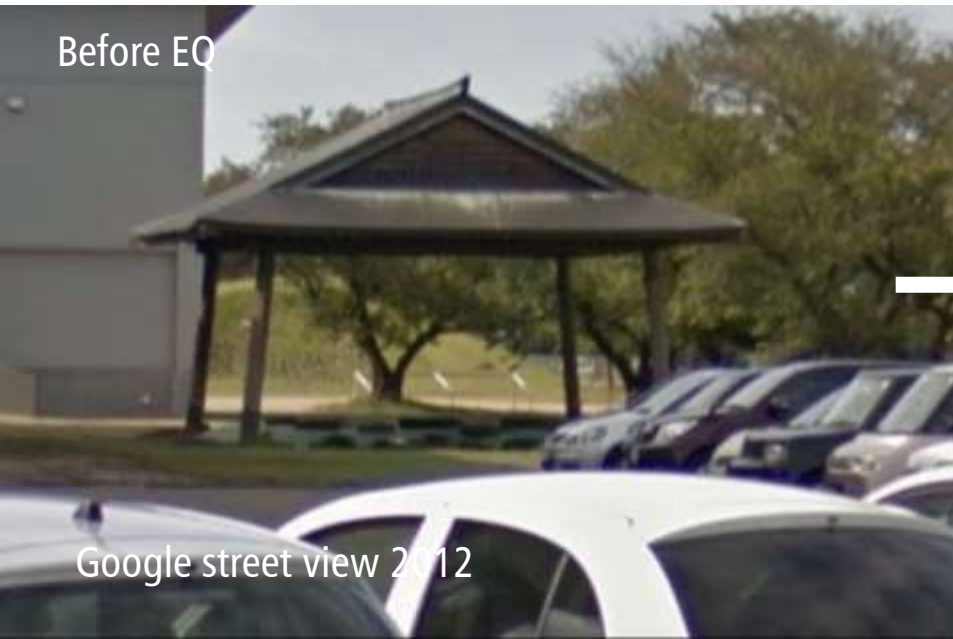
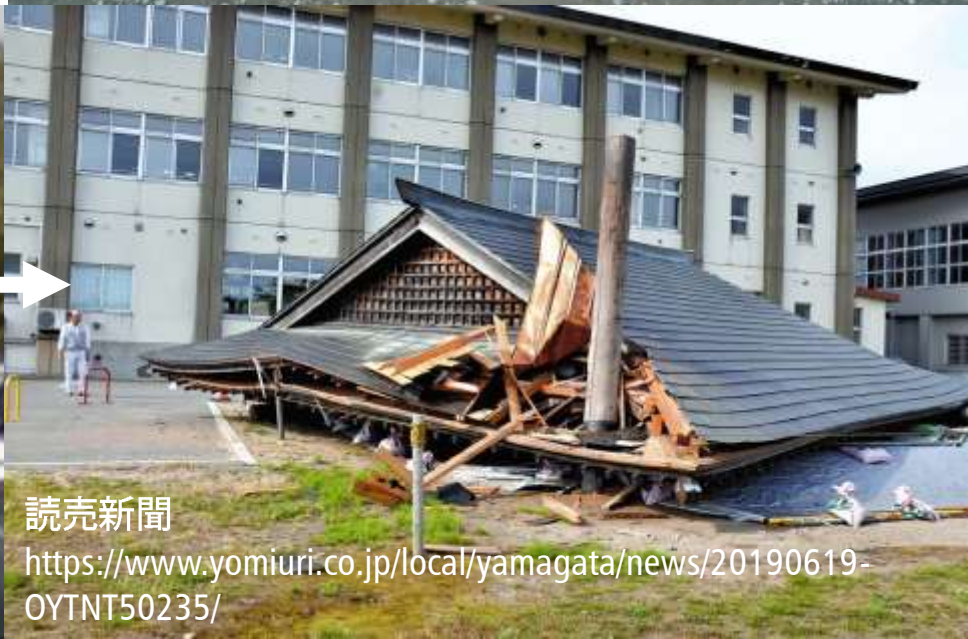
# 鶴岡 | Truruoka, YMT003 (JMA intensity 5+)

- Fall of roof tiles (<1%)
- Collapse of sumo field
- Liquefaction in front of the main station
