The 2007 Noto Peninsula, Japan Earthquake (M_w 6.7): Damage to Wooden Structures

Masumi Yamada¹, Sun-Cheon Park¹, and Jim Mori²

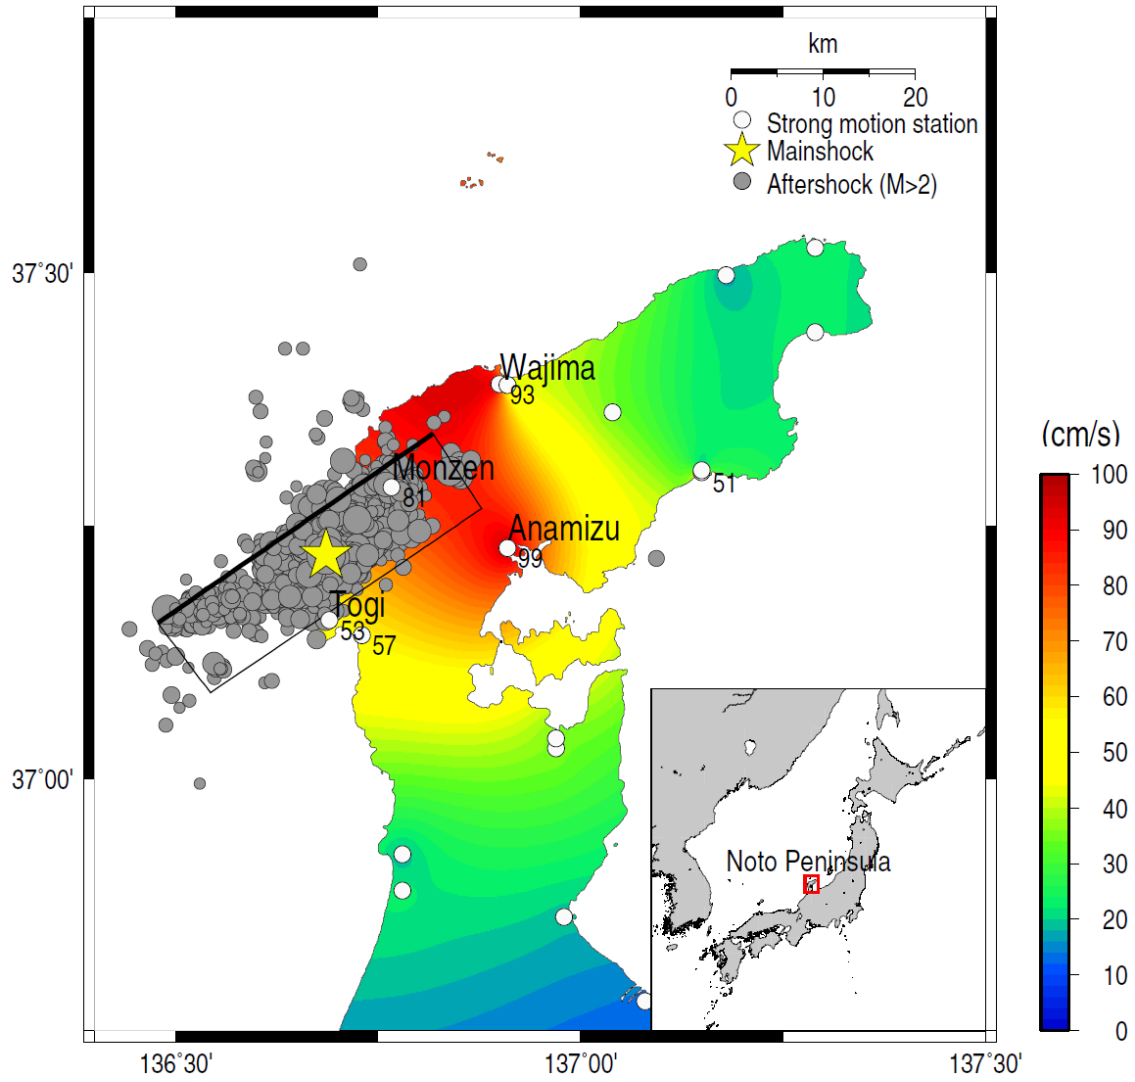
The 2007 Noto Peninsula earthquake was recorded by many strong motion stations. Figure 1 shows the distribution of horizontal peak ground velocity, PGV (the larger amplitude of the two horizontal components). The PGV values exceeding 90 cm/s at Anamizu and Wajima are due to soft soil amplification.

Figure 1: A contour map of PGV distribution from strong motion records. The numbers are added for PGV values greater than 50 cm/s. The fault geometry for the mainshock and aftershock distribution for the week after the mainshock ($M_{jma} > 2.0$) is also shown.

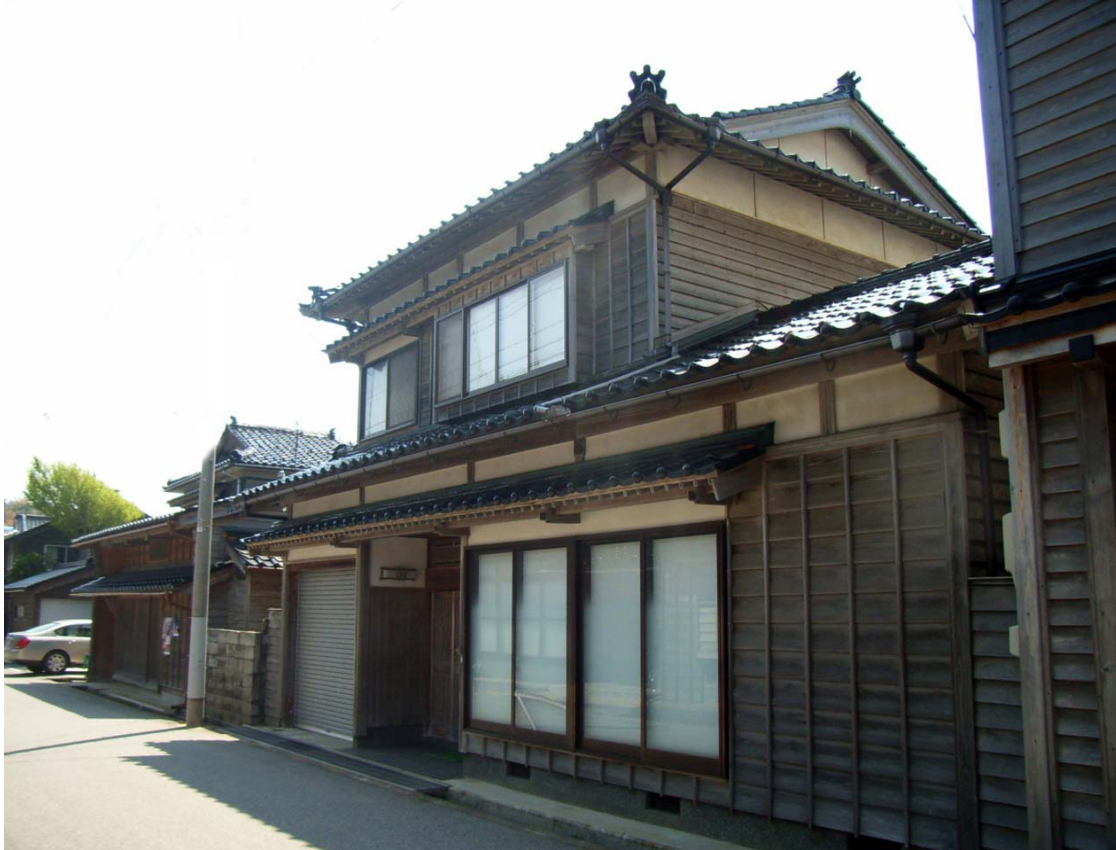
The typical houses in Monzen are constructed in a traditional style, consisting of column and beam structures with mud plaster walls (Figure 2). The roof is covered by Japanese tiles. Along with the long history of the town, most houses have an average age of 40~50 years, and some are more than 100 years old. People continually use these old buildings with occasional expansions and repairs. A special structural feature in this area is wooden boards nailed on the wall (Figure 2). The boards protect the mud plaster wall from the strong sea breeze, and improve the seismic performance of the houses.

Figure 2: Typical wooden house in Noto. Houses are constructed in the traditional column and beam structure.

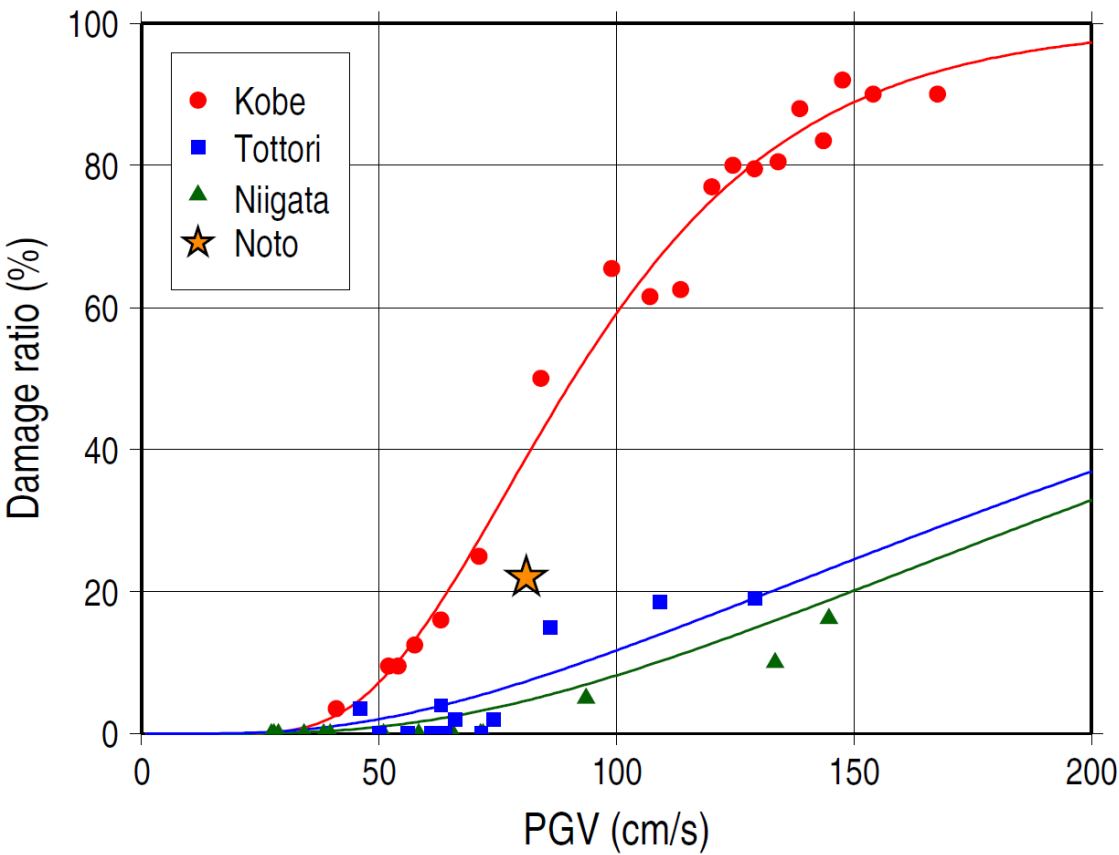
Figure 7 shows the relationship between damage ratio of Rank C wooden structures and PGV for several recent earthquakes in Japan. PGV values are taken from the larger horizontal component of the strong motion record. Since the strong motion network at the time of the Kobe earthquake was not as dense as these days, PGV values were estimated from damage ratio functions of 1st or 2nd story buildings (Murao

In Figure 7, the PGV of the 2007 Noto Peninsula earthquake is obtained not from a strong motion record, but the empirical relationship in equation (1). The damage ratio is the percentage of Rank C damage in section Hb, where the JMA station is located (see Figure 5(a)). The damage ratio for the 2007 Noto Peninsula earthquake is higher than that of the 2000 Western Tottori and 2004 Mid-Niigata earthquakes, and lower than the 1995 Kobe earthquake.

Figure 7: Damage ratio of wooden houses for different earthquakes.
