# <sup>1</sup> Building Damage Survey and Microtremor Measurements for the

# <sup>2</sup> Source Region of the 2015 Gorkha, Nepal Earthquake

Preprint submitted to Earth, Planets and Space on May 31, 2016

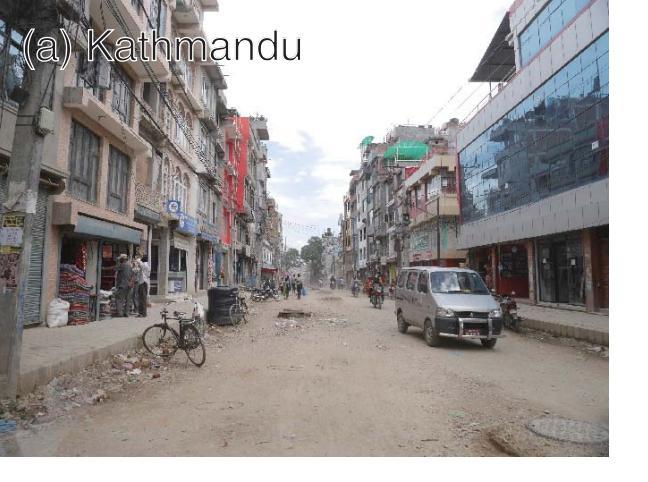
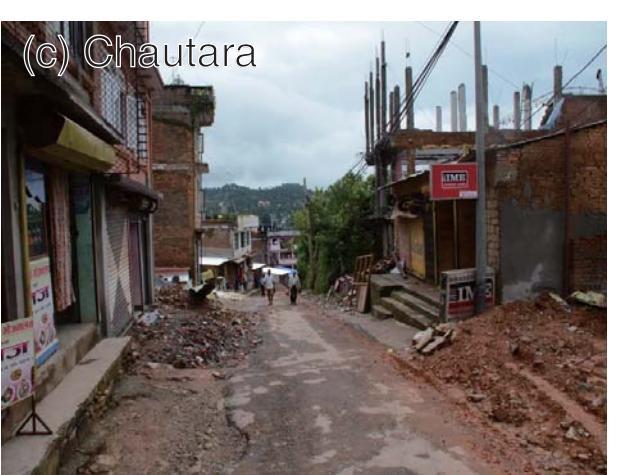
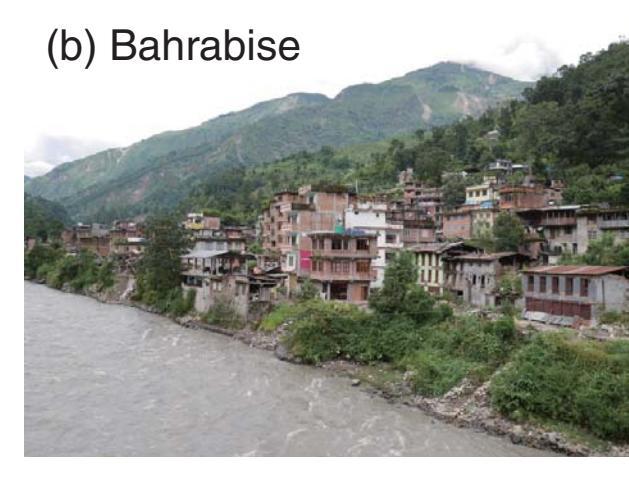
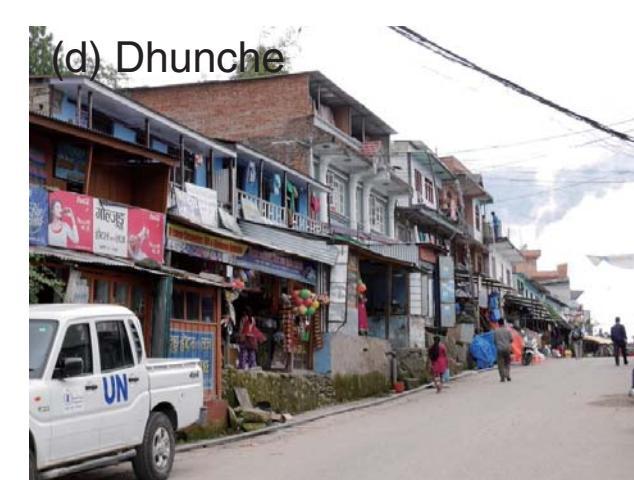
<sup>117</sup> Next we focus on four major population centers (Kathmandu, Bahrabise, Chautara, and Dhunche) and <sup>118</sup> describe the city properties, building types, and damage (see Figures 5 and 6).

- Figure 5. Photo of the areas where damage surveys and microtremor measurements were carried out.
- Figure 6. Location of mictotremor measurements and H/V spectra in each town. Left: Map of the surveyed area (white painted area) and location of H/V measurements (yellow circles). Google Earth was used to make maps. Right: H/V spectra measured at the location.

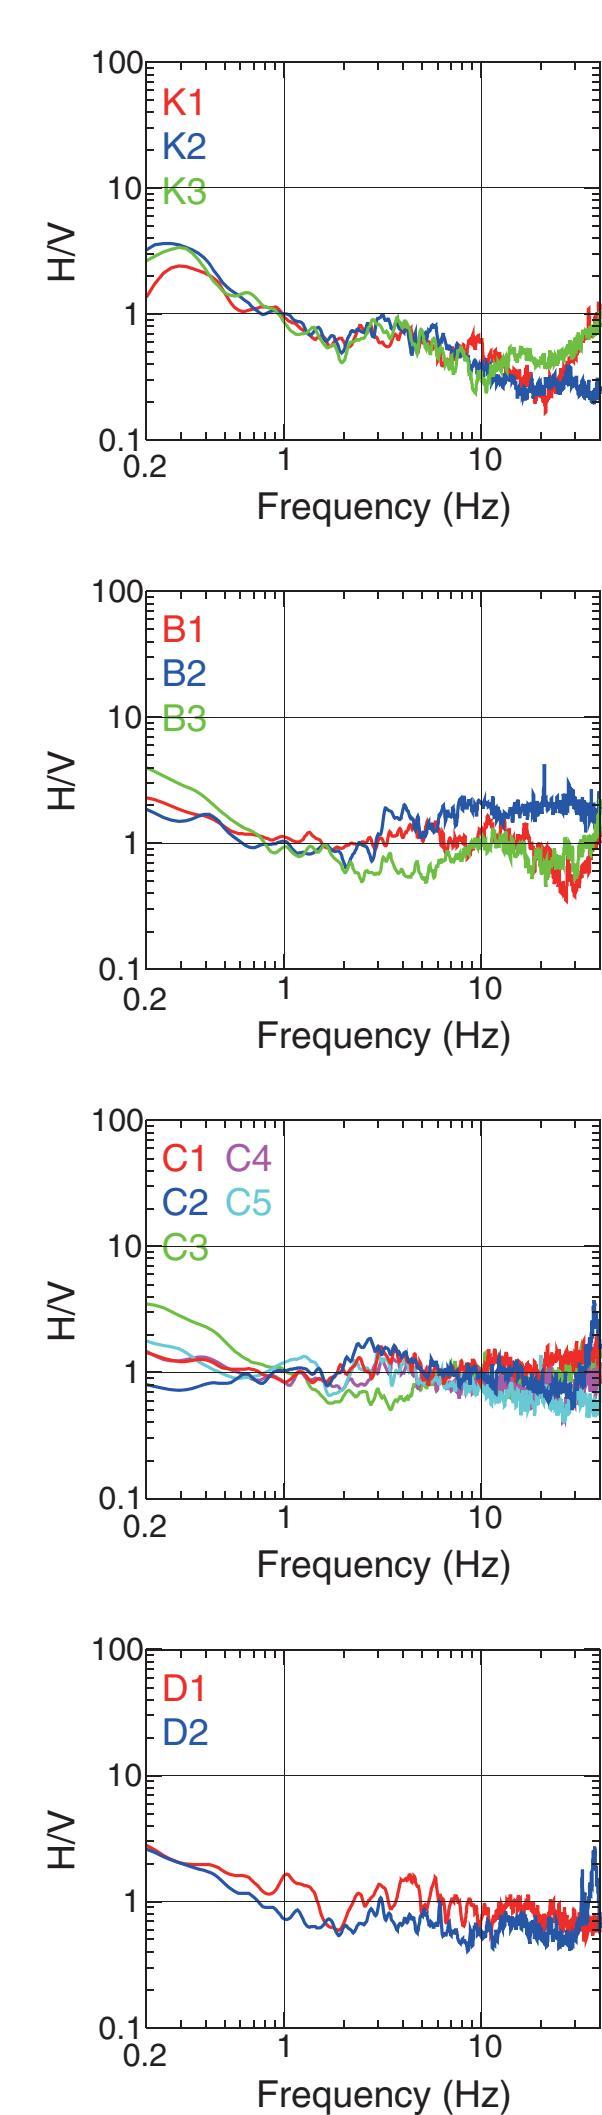
Figure 6 shows the H/V spectra of the ambient noise measured in Kathmandu, Bahrabise, Chautara, and Dhunche. The location of the measurement in Kathmandu is near the USGS strong motion station, and others are close to the centers of the towns. We performed multiple measurements within the damage <sup>146</sup> survey area, and confirmed that the major characteristics of the spectra were consistent among the <sup>147</sup> measurements.
