# 1 **Wooden building damage analysis in Mashiki** 2 **town for the 2016 Kumamoto earthquakes on** 3 **April 14 and 16**

4 **Masumi Yamada<sup>a)</sup>, Junzo Ohmura<sup>b)</sup>, and Hiroyuki Goto<sup>c)</sup>**

5 The 2016 Kumamoto earthquakes caused serious building damage in Mashiki town.  
6 Since two large earthquakes occurred within an interval of 28 hours, it is difficult  
7 to separate the damage caused by each of these earthquakes. We analyzed aerial  
8 photos of the center of Mashiki town taken before and after the second event, which  
9 allow us to separate the damage due to the two earthquakes. Our analysis shows that  
10 building damage was concentrated especially on the river terrace of the Akitsu river,  
11 and there were almost no collapsed buildings in the south of the damaged area. The  
12 pattern of damage distribution of the two events was similar, which suggests that  
13 the damage to the wooden buildings was caused by local conditions. The analysis  
14 of past aerial photos showed that the heterogeneity of the damage distribution is  
15 difficult to explain by only the building age. The cause of this heterogeneity was

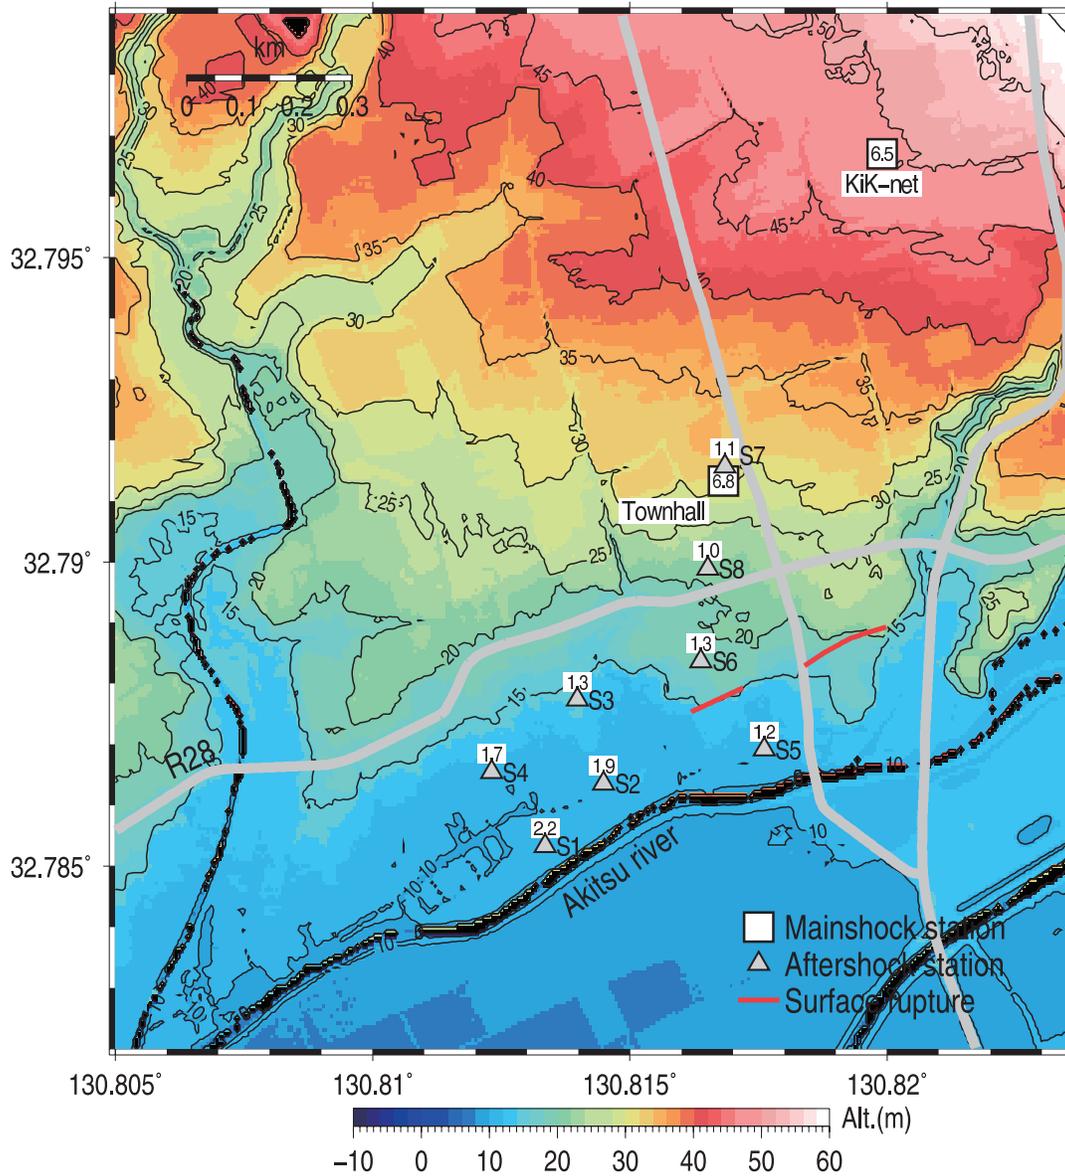
**Figure 2.** Topographic map of Mashiki town with JMA seismic intensity of April 16 event (square symbols) and aftershock on June 12 (triangle symbols). The red lines show the surface rupture (Geological Survey of Japan, 2016).

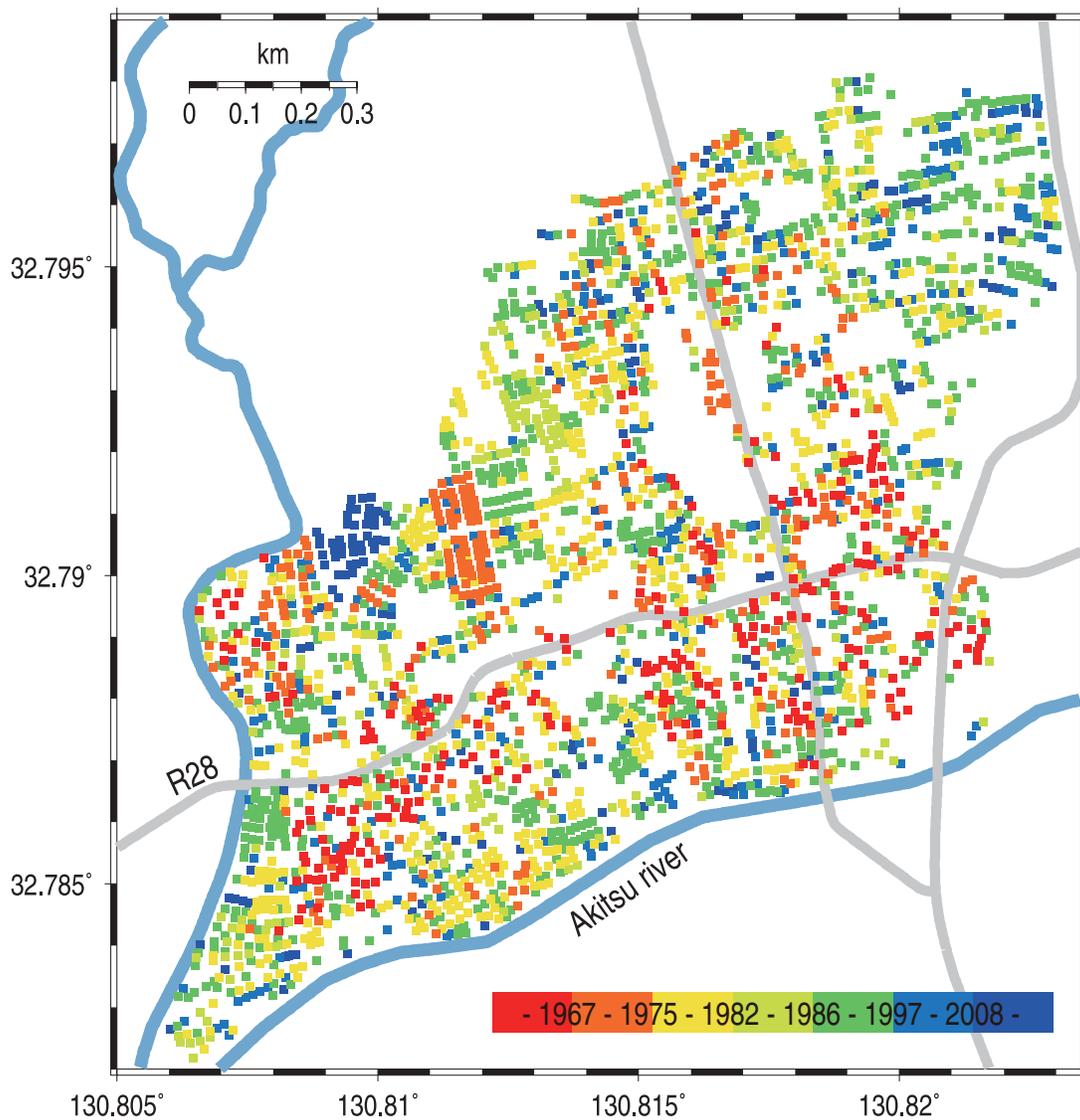
159 Figure 11(a) shows the percentage of collapsed buildings according to different construction  
160 periods. The damage distribution identified from the aerial photo is used for this analysis. The  
161 age was estimated using the previous aerial photos, and the distribution in age of the buildings is  
162 shown in Figure 12. Figure 11(a) shows that there was a strong correlation between the building  
163 age and the collapse ratio, and that the older buildings had higher collapse ratios. The buildings  
164 over 50 years old had a very high collapse ratio of 40%. The number of buildings analyzed  
165 for the different periods is shown in Figure 11(b). The figure shows that many buildings were  
166 constructed in the 1970s and 1980s, but that new buildings have been continually constructed,  
167 even during the last 10 years.

**Figure 12.** Age of buildings detected from the aerial photo analysis. Colors show the construction periods.

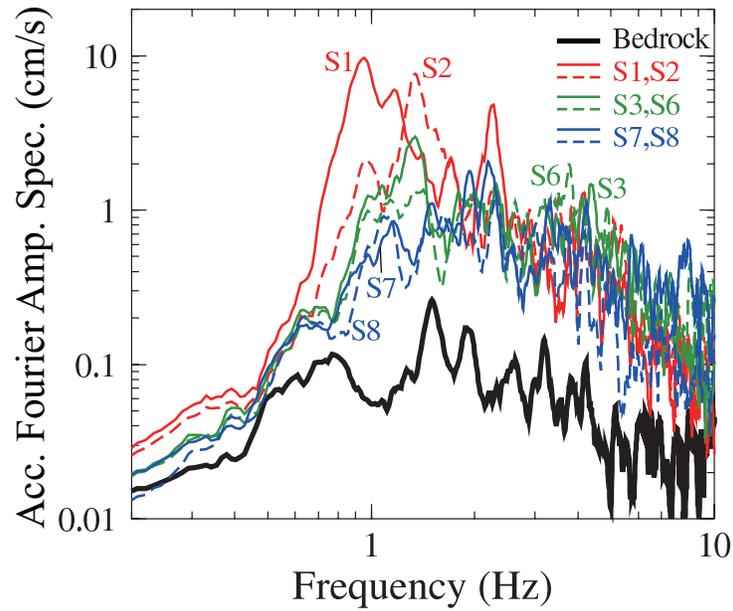
175 The triangle symbols in Figure 2 show the seismic intensity for the Mj 4.3 aftershock that oc-  
176 curred on June 12. The observed intensity had a close correlation with the topography except  
177 for station S5. Stations S1 and S2, closest to the Akitsu river and considered to be located on  
178 thick sediments, recorded larger ground motions. Stations S7 and S8, at higher elevation, ex-  
179 perience smaller amplification and recorded smaller ground motions. Stations S3 and S6 have  
180 site properties that are intermediate between these two groups. The pattern of site amplifications  
181 was also clearly visible in the frequency domain. Figure 14 shows the Fourier amplitude spectra  
182 of the EW component for certain selected sites. S1 and S2 experienced higher amplification in  
183 the 1–2 Hz range compared to S7 and S8, while S3 and S6 experienced moderate amplification  
184 in the same frequency range.

**Figure 14.** Fourier amplitude spectrum of EW component for the aftershock. Black line shows the KiK-net borehole record, and colored lines show the records at temporal stations shown in Figure 2.
